ROBERT J. HACKMAN
U. S. Geological Survey
Washington, D. C.

Interpretation of Alaskan Post-Earthquake Photographs*

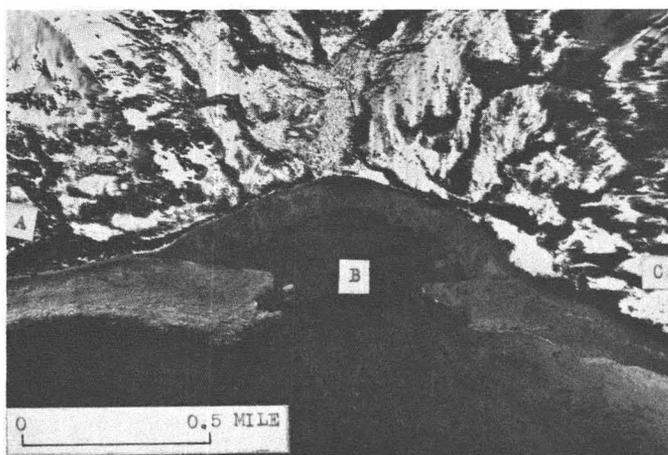
FIG. 2. Vertical aerial photograph showing location (*ABC*) of reactivated fault on Montague Island. (Photograph courtesy U. S. Department of Commerce.)

So far as known, all faults affected by the earthquake are old faults that were reactivated. Several such faults were identified in the field by George Plafker, U. S. Geological Survey, in June 1964 (written communication) and were also identified on the photographs. Figure 2 shows one of these faults where it crosses Hanning Bay on the west side of Montague Island.

The linear trace of this fault and the relative displacement of rocks on one side of the fault with respect to the other are apparent on the photograph. Obvious emergent features, near the intersection of the fault with the coastline, demonstrate major movement in which the west side (toward bottom of photograph) moved up. The plane of the fault appears to be nearly vertical on the aerial photograph. As known older faults in this same general area have similar displacements, classification of this fault as "new" or "reactivated" is uncertain. It is possible that with the addition of tidal data and a knowl-

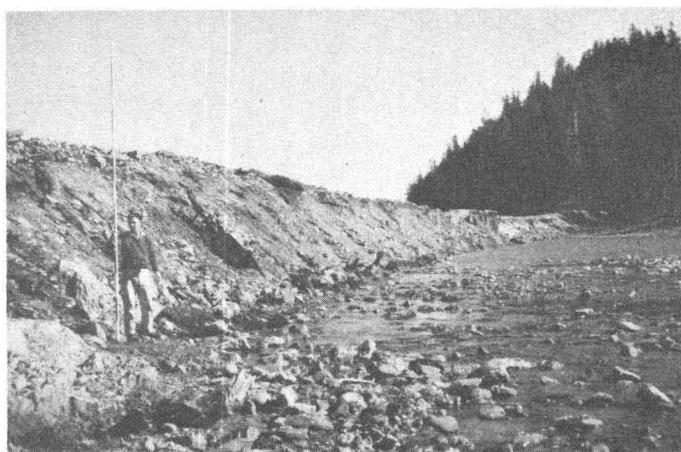
Figure 3 is a photograph of the fault which occurs in a cove just south of Hanning Bay. The vertical displacement along the fault is 13.5 feet in the foreground and 16.3 feet at

the beach ridge in the background. The nearly vertical rock ledge can be seen in places along the escarpment.

FIG. 3. Ground photograph of Hanning Bay fault in a cove just south of Hanning Bay. (Photograph by George Plafker.)

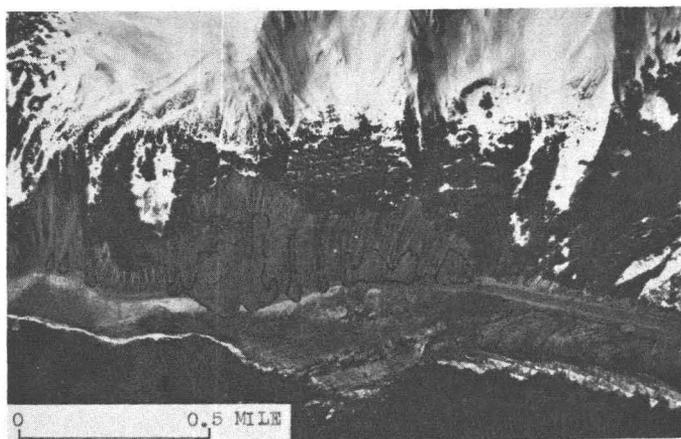
photography. Figure 4 shows a portion of the eastern shore of Montague Island where photointerpretation criteria suggest an uplifted shoreline. Here, numerous landslides overlap the strand line. As the slides were probably triggered by the earthquake, and wave action had not altered them in the three weeks between the earthquake and the time of photography, the beach has probably been uplifted. The uplift of this coastline has been substantiated by Plafker's field investigations.

FIG. 4. Vertical aerial photograph showing evidence of recently uplifted coastline. Outlined areas are recent landslides partially covering former beach. (Photograph courtesy of U. S. Department of Commerce.)

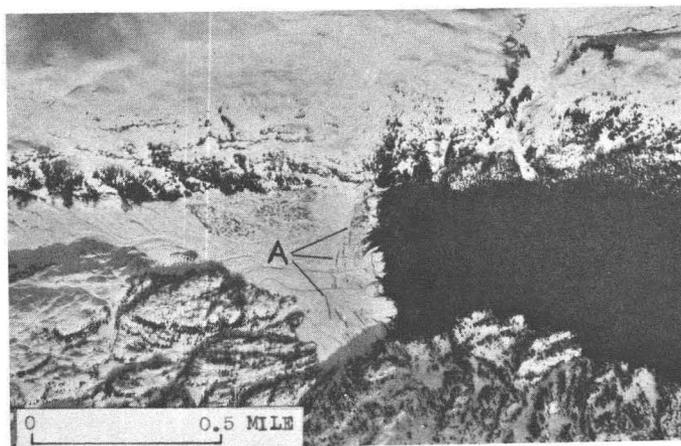
Cracks in surficial material were recognized in some isolated places, although none were as conspicuous as those in the Anchorage area (Grantz, et al., 1964). Cracks in surficial material at the head of Blue Fiord on the west side of Prince William Sound (Figure 5)

FIG. 5. Vertical aerial photograph showing location of cracks (*A*) in surficial material at the head of Blue Fiord. (Photograph courtesy of U. S. Department of Commerce.)

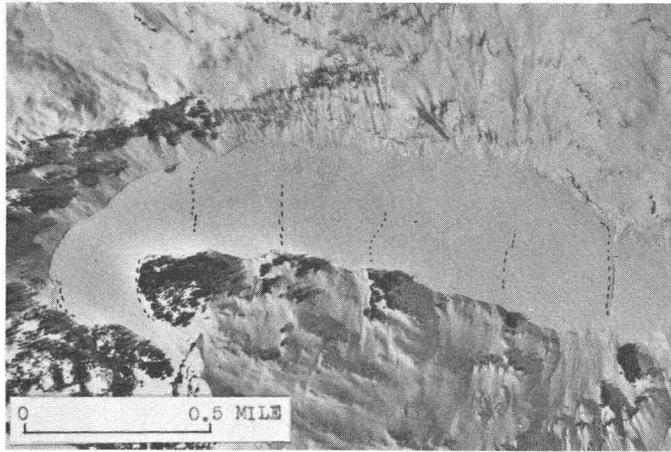
These pressure ridges are a result of the earthquake and generally are oriented in a direction perpendicular to the direction of the shock wave (Grantz, et al., 1964). The pressure ridges recognized in the area of study generally have a predominant northeast trend west of Prince William Sound, and a west trend north of Prince William Sound. Figure 6 shows the location of some pressure ridges produced by the earthquake on an unnamed lake on the mainland just north of Esther Island.

FIG. 6. Vertical aerial photograph showing location of pressure ridges (dotted lines) on ice covered lake. (Photograph courtesy of U. S. Department of Commerce.)

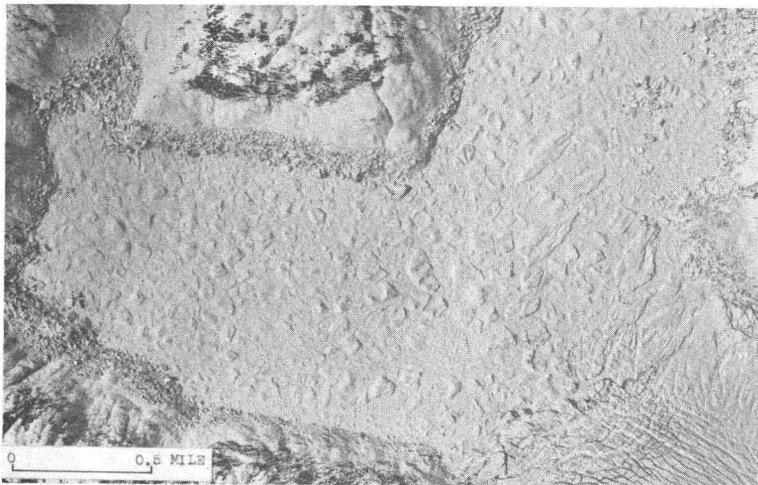
Considerable broken ice resulting from the earth tremors was observed on many of the larger lakes. On some lakes breakage resulted from the accumulated weight of snow and rock slide material. A triangular unnamed lake, fed by an arm of the Columbia Glacier and located several miles northwest of Columbia Bay, appears to have partly drained as a result of the earthquake. Large contiguous blocks of ice along the shoreline seem to have dropped downward without rotation (Figure 7).

FIG. 7. Vertical aerial photograph showing evidence of recent lowering of water level on an unnamed lake. (Photograph courtesy of U. S. Department of Commerce.)

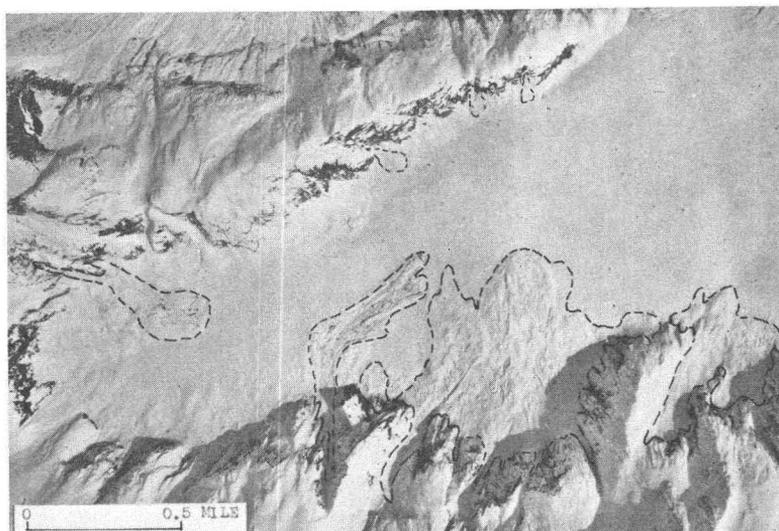
FIG. 8. Vertical aerial photograph showing location of recent avalanches and snow slides (dashed lines) on Contact Glacier. (Photograph courtesy of U. S. Department of Commerce.)

normal incidence of slides in the area, the fresh appearance of most of these features strongly suggests that they are of very recent origin and were probably triggered by the Good Friday Earthquake and/or subsequent after shocks. Figure 8 shows some very recent avalanches on Contact Glacier.

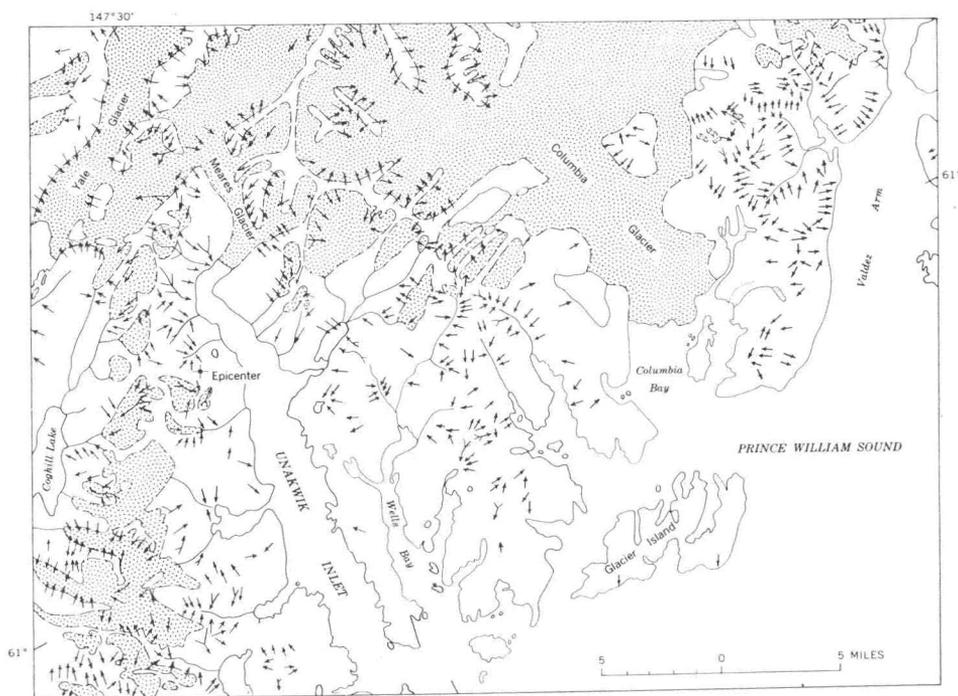
FIG. 9. Map showing distribution and direction of post-earthquake slides and avalanches around epicenter of earthquake of March 27, 1964.

The longest avalanche scar is three miles long and extends from an elevation of 5,000 feet to sea level near the head of Unakwik Bay. Several miles to the south is another avalanche two miles long. Both are within several miles of the epicenter. Figure 9 shows the distribution of slides in the epicentral area.

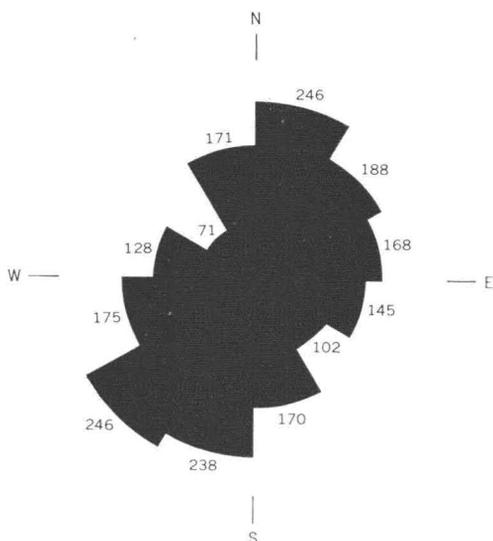
FIG. 10. Rosette graph of trends of 2,036 avalanches and slides in area of blanket photo coverage.

A rosette graph (Figure 10) summarizes the directions of slides in the area of blanket photo coverage. In plotting the graph, only the direction of the tail or starting place of the slide was used. The graph shows preferred directions of slides to the southwest and to the northeast. There is a noticeably smaller number of slides trending to the southeast and northwest.

Prevalence of northwest-southeast trending valleys with very steep sides facing northeast and southwest in the area west of Prince William Sound probably accounts for the directional distribution of the slides. Without a detailed analysis of the topography with
