DAVID W. GAUCHER
Calspan Corporation
Buffalo, NY 14221
JAMES D. TURINETTI, CAPT, USAF
Rome Air Development Center
Griffiss AFB, NY 13441
KENNETH R. PIECH
Calspan Corporation
Buffalo, NY 14221

Special Color Analysis of Runway Conditions

Regions of cracking or depressions in the runway at Thule Air Base, Greenland were determined from color aerial photography.

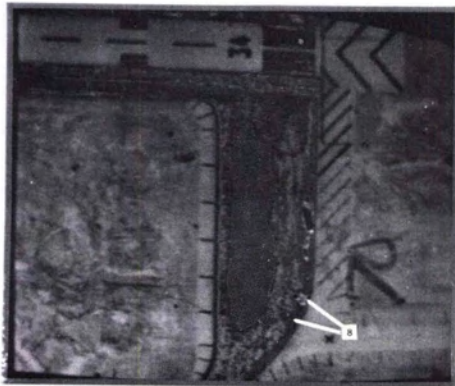
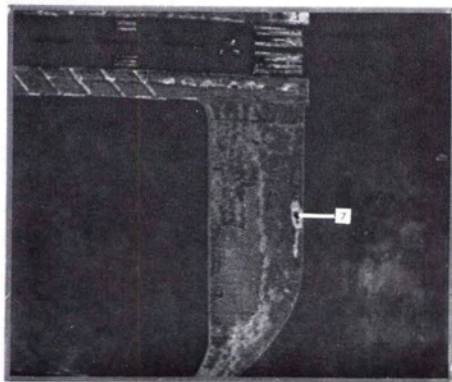
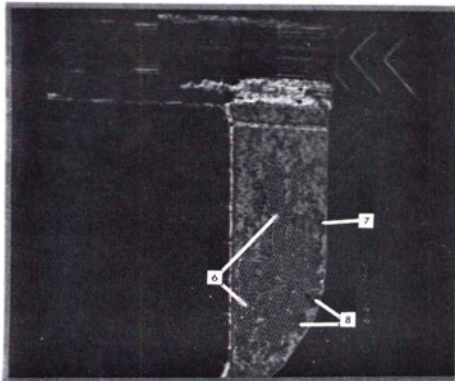
FIG. 2. Comparison of red, blue, and red/blue ratio information.

A COMPARISON OF THE DISPLAYS PRESENTED BY THE RED AND THE BLUE SEPARATIONS VERSUS THE RED/BLUE RATIO DISPLAY. THE DENSITY PATTERNS OF THE RED/BLUE RATIO DISPLAY ARE QUITE DIFFERENT FROM THOSE OF THE INDIVIDUAL SEPARATIONS.

- 6 - DETERIORATED SURFACE
- 7 - TIRE MARKS
- 8 - ENGINE BLAST MARKS

Areas 7 and 8 of the runway display also were examined carefully in order to determine whether these areas contained cracks, or actual marks on the runway. This area is enlarged in Figure 2. Areas 7 and 8 are apparent on both spectral layers as well as the ratio display because these areas are tire marks and engine blast marks, respectively. They appear as dark areas on the original imagery and hence are highly visible in each color layer, as well as on the ratio display. The red and blue film layers were used in this manner to key the interpreter to possible false alarms.

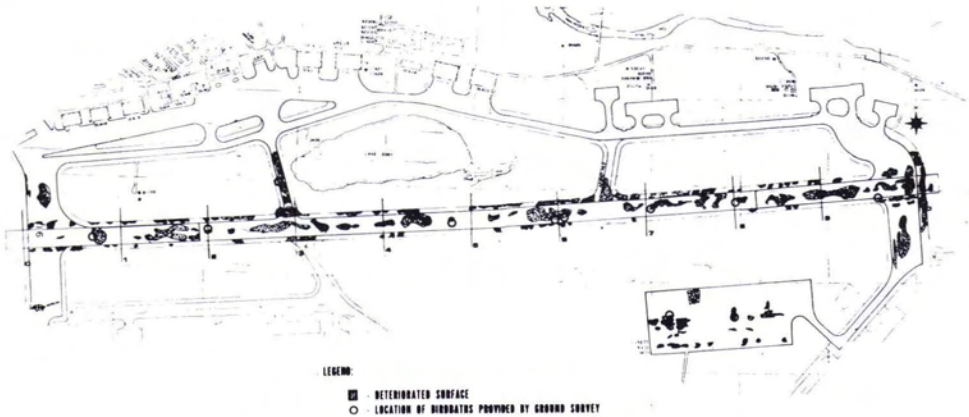
FIG. 3. Runway surface deterioration map, Thule.

The runway map (Figure 3) is also annotated with black circles which show the actual ground locations of known surface cracking. Photos of these cracks and depressions at various locations along the runway are presented in Figure 5. The depressions, called "bird baths," can appear overnight, and often reach a depth of one foot. Figures 5a and 5b show depressions which are located at the 1500-foot and 2500-foot markers on the runway map.

The problem areas delimited on the runway map were transferred from the ratio displays. The areas annotated at the 750-foot and 8000-foot markers coincide with bird baths that were outlined on a map provided by Thule personnel.

The analysis located many more problem areas along the runway length than were noted on the maps provided by base personnel. The shaded areas on the map, which coincide with the darker blue areas on the ratio display (Plate 1), are probably areas with a denser cracking pattern or deeper cracks, both of which suggest a very unstable sub-base. The tapered runway edges showed deterioration where they met adjacent soil areas. This is probably due to water erosion along and under the thinner shoulders of the runway.

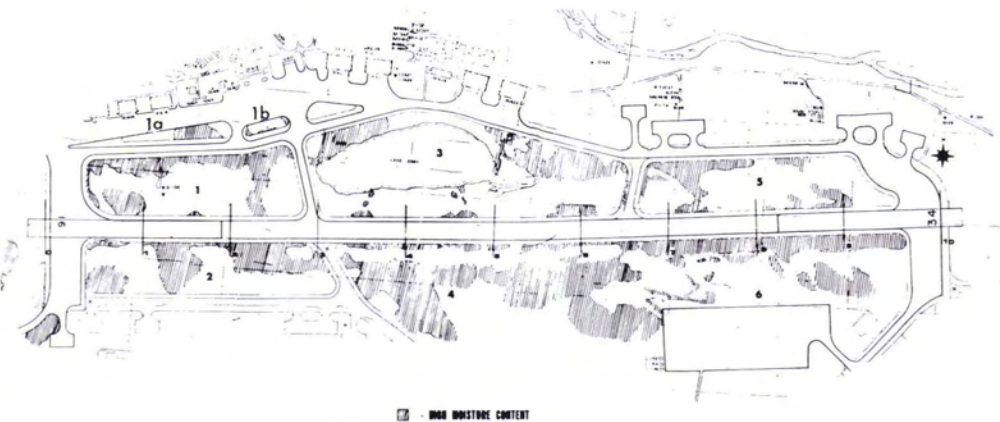
FIG. 4. Soil moisture map, Thule.

Area 1 of the soil map (Figure 4) is a shallow, rectangular basin with the moisture pattern appearing primarily on its periphery. The pattern extends beneath the taxiway into areas 1a and 1b. At several points adjacent to the main runway, patterns appear that suggest

a substrata flow of moisture between areas 1 and 2. These patterns occur at footage markers 1500 and 2400, and coincide with runway surface deterioration at these locations, as shown in areas A and B of the soil display (Plate 1). The pattern in area 1 seems to branch across the western north/south taxiway and join with Lake Eddy in area 3 (area C on Plate 1).

A second major flow pattern appears to exist between areas 2 and 3. This moisture pattern occurs in the northeast corner of area 2 and extends into the southwest corner of area 3, continuing into Lake Eddy. This is suggested by the yellow pattern presented in areas B and D on the soil display (Plate 1). Cracking in the runway surface at area 3 in the runway display (Plate 1) reinforces this interpretation. A third pattern, which also appears to have its terminus in Lake Eddy, exists at the 4500-foot marker between soil areas 3 and 4. This pattern coincides with area E on the soil display, as well as with a bird bath shown on both the runway display

A fourth flow pattern across the runway is suggested at the 6000-foot marker where moisture is found on both sides of the runway, and evidence of runway deterioration (refer to areas I and K on soil display Plate 1).

A final moisture pattern exists over the length of area 6 paralleling the south edge of the main runway. Lesser moisture patterns exist in area 5 which suggest some subsurface crossflow with area 6. Runway cracks at markers 8000 and 9000 bolster this interpretation. This pattern is suggested by areas J and L on the soil display.

The overall moisture pattern indicates a general southeast to northwest movement of subsurface water. Such movement is consistent with the position of the river north of the airfield, and with the high ground located south of the field.

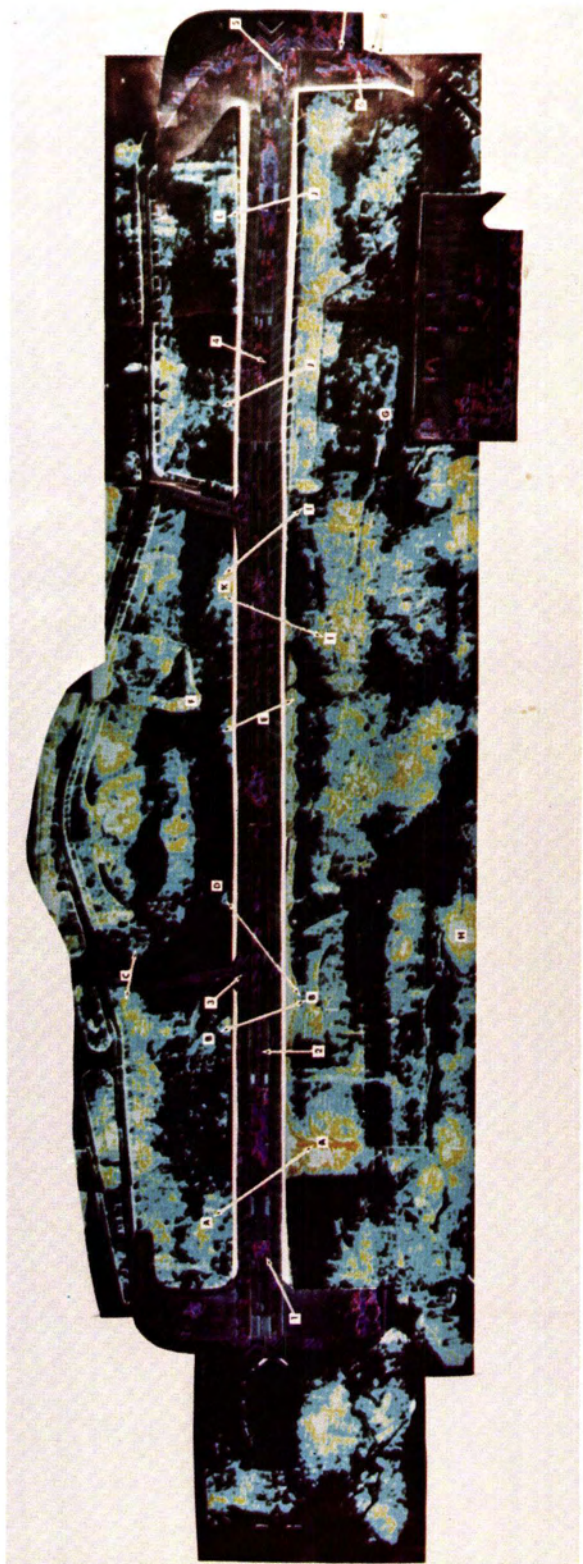
PLATE I. Working mosaic of runway and soil ratio displays.

The runway display (Plate 1) shows areas of high texture (cracked areas) in blue and red. Area 1 is a patch of extreme cracking, evidenced by the high red-to-blue ratio presentation encoded in blue. This area coincided with a "bird bath" that was annotated on a base map provided by Thule personnel.

Areas 2 and 3 were points which required careful inspection on the original imagery, as well as on the ratio display. The linear blue pattern coincided with black tire marks present on the original scene. Their position in the runway center and general appearance indicate the pattern is caused by tire marks and not by surface cracking. The large blue patch of area 3 also contained many tire marks; however, the extent of the blue area indicates that this area is affected by cracking

in addition to the presence of tire marks. The entire taxiway appears to be deteriorated on large-scale original imagery and this is reinforced by the amount of blue present along the taxiway.

Area 4 clearly shows what tire marks look like when found completely isolated on relatively good pavement. This is a point where an aircraft turned on the runway, as evidenced by the curved pattern on the display.

Area 5 appears to be a spot where deterioration took place and was subsequently patched. The linear pattern on the display coincides with a trough-like feature on the original imagery which appears to be an asphaltic patch.

One such anomaly occurs in area F. The area outlined is a man-made mound with steep, sloping sides. The sides of the mound are light reddish soil which has a high red-to-blue ratio independent of the presence of

any moisture. The base ratio level from which moisture changes are measured for this soil is therefore much different from the other soil in the target scene. This same phenomenon occurs at area G, where the side slope of a gully is reflecting higher in the red than any of the surrounding soils.

On the soil display, ponds with water and/or ice present a low red-to-blue ratio. Area H is a pond, but is displayed by a high red-to-blue ratio. This is because the pond is shallow and the bottom of the pond is visible. The bottom material is a high red reflector, thus raising the red-to-blue ratio of the target.

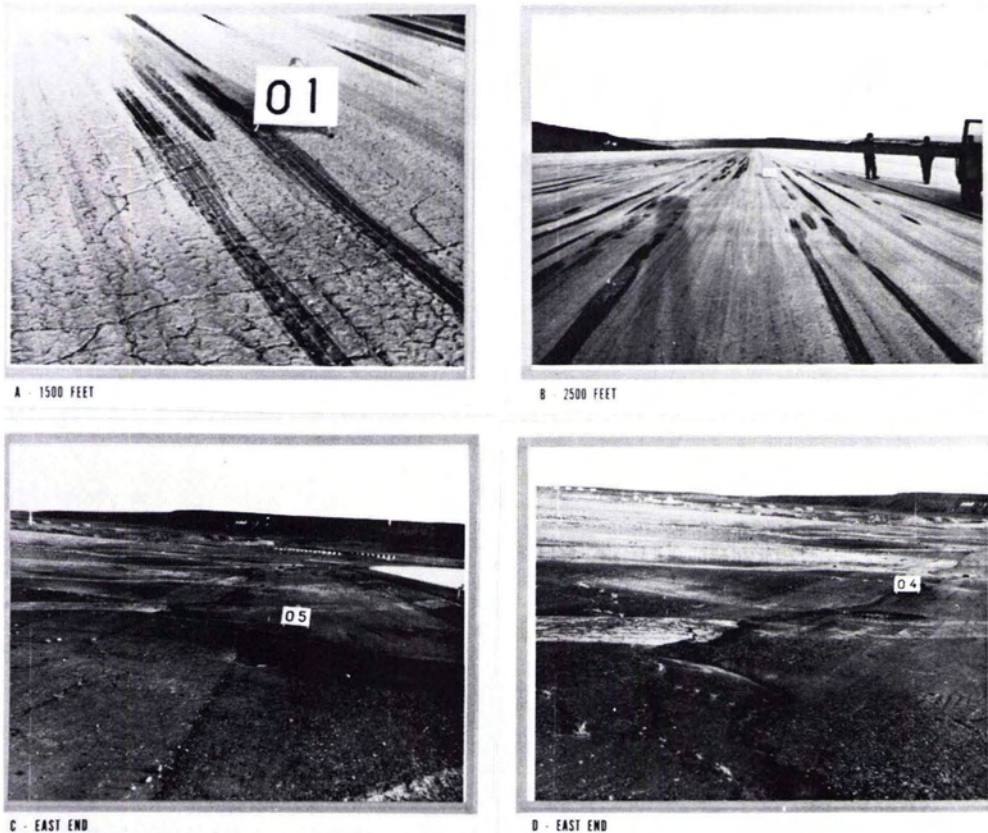
FIG. 5. Ground photos of birdbaths and cracks in runway surface.

The ratio analysis technique also indicated problem areas on the East end of the runway in the overrun and apron areas. This was verified by Figures 5c and 5d and ground survey information.

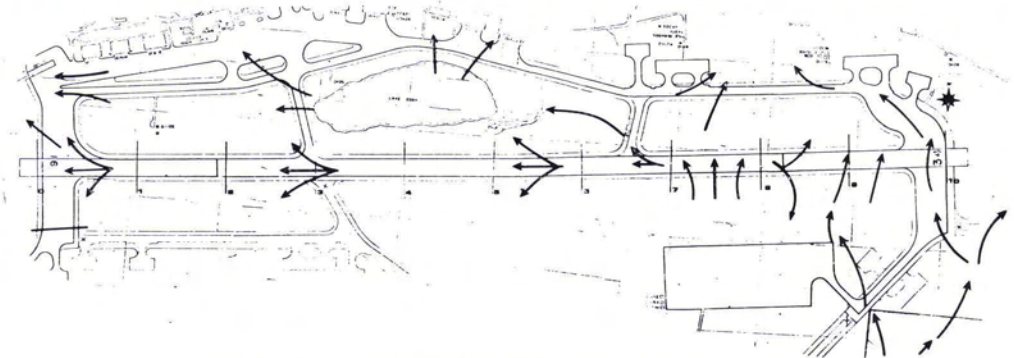
FIG. 6. Subsurface moisture flow trends at Thule Air Base.

The results of all the analyses of Thule AB were presented at a joint conference in Colorado Springs, Colorado so as to ascertain the extent of moisture damage and develop remedial measures. Figure 6 shows the general moisture trends which resulted from the conference. When compared to the patterns previously presented in Figures 3 and 4, it can be seen that SCAT analysis confirms this flow pattern.
