KENNETH R. PIECH*
J. E. WALKER
Cornell Aeronautical Lab., Inc.
Buffalo, N. Y. 14221

Outfall Inventory Using Airphoto Interpretation

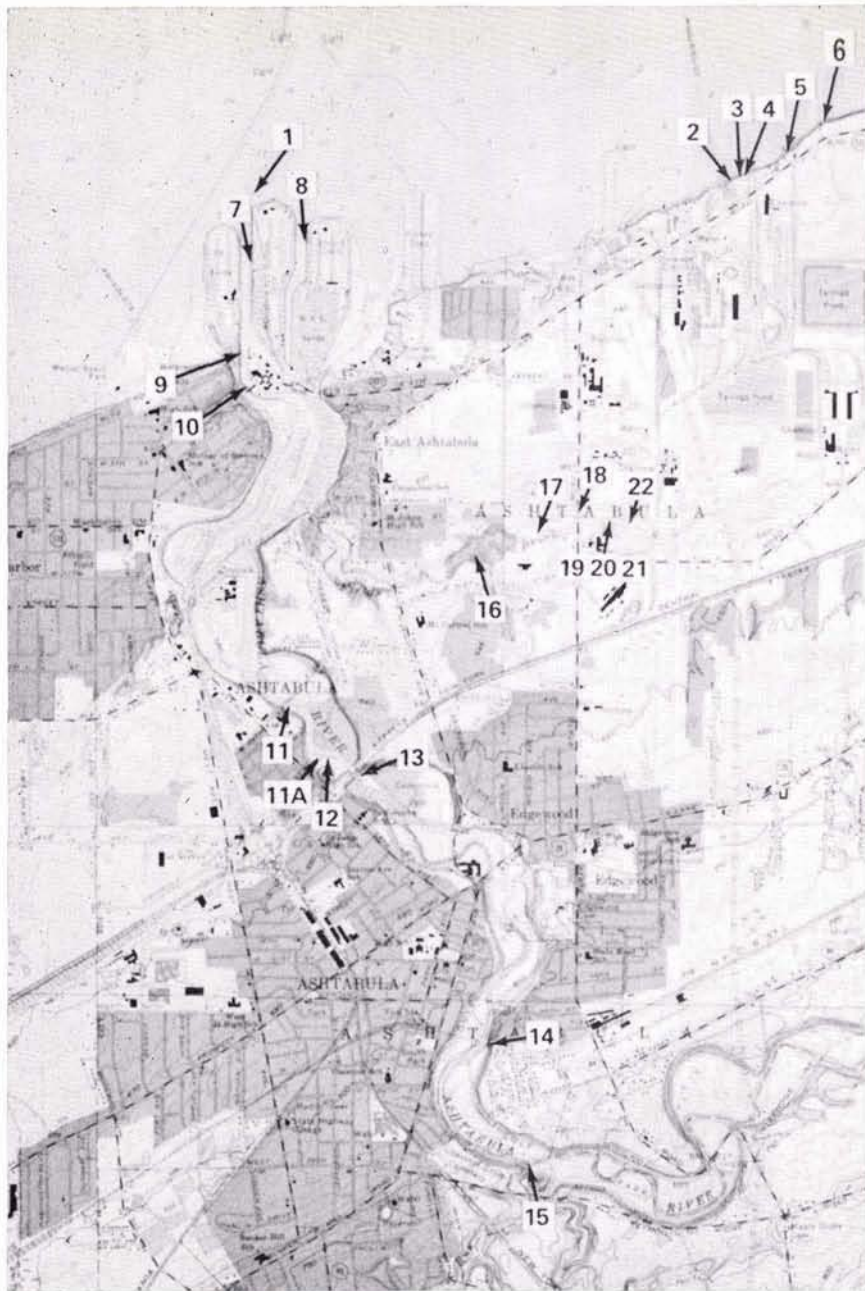
FIG. 1. Ashtabula and Fields Brook outfalls.

Eighteen outfalls and four outfall clues. The numbers refer to the maps of Figure 1. The method of outfall detection is indicated by the key: *A*, discoloration; *B*, discharge structures; and *C*, drainage patterns and interpretation of complexes away from the shore.

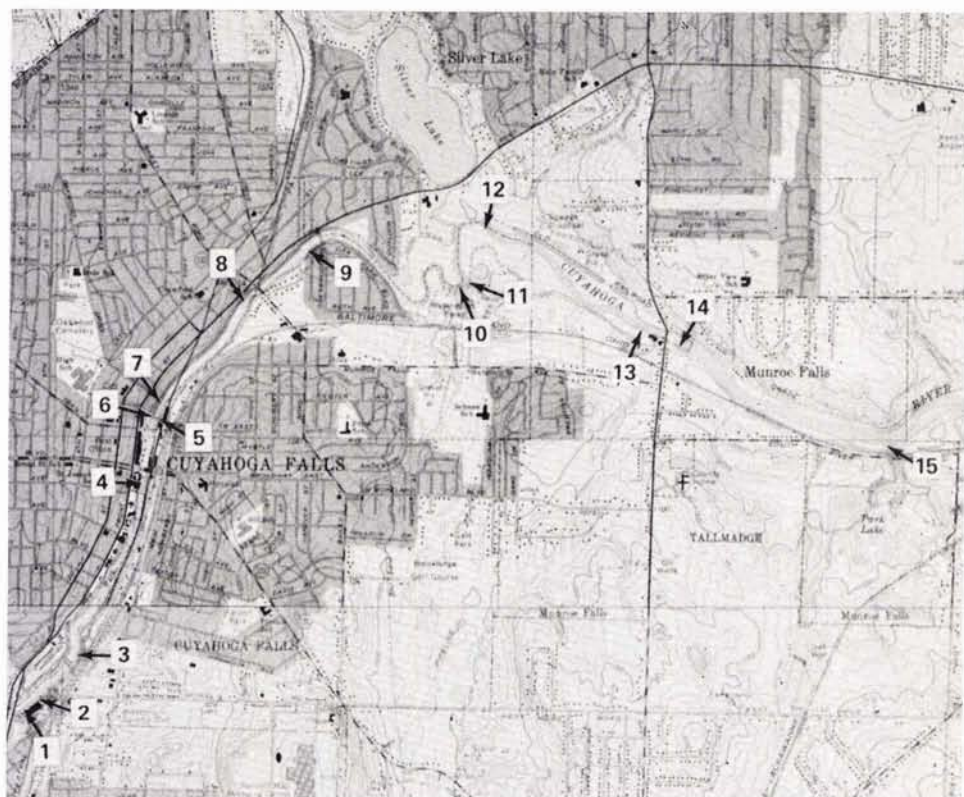
FIG. 2. Cuyahoga River outfalls.

The numbers refer to the map of Figures 2 and 3. The method of detection is indicated by the key: *A*, discoloration; *B*, discharge

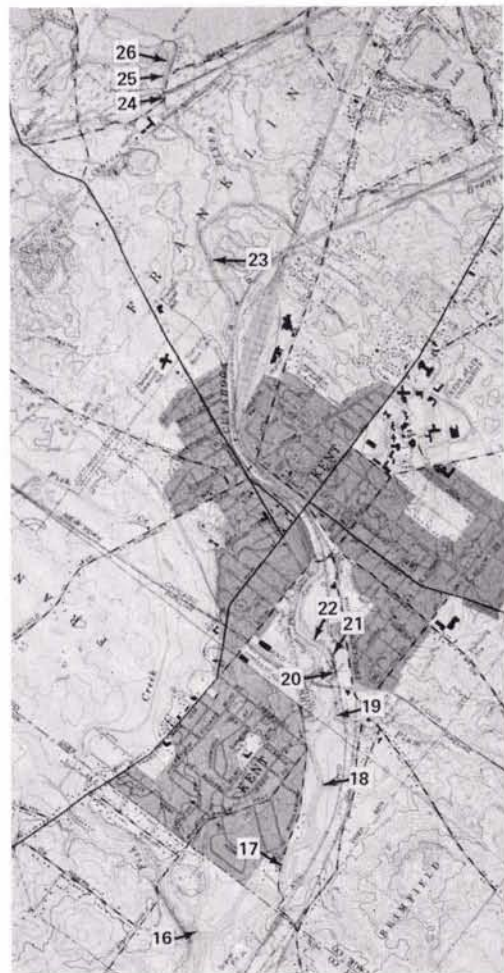
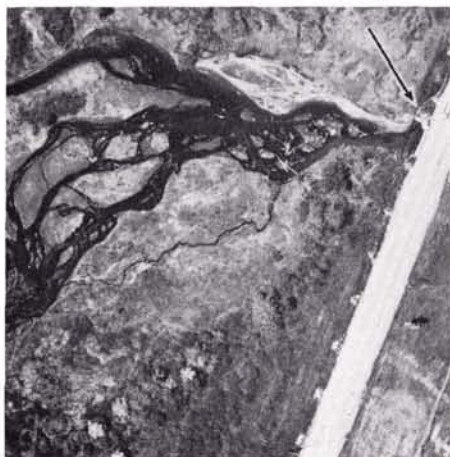
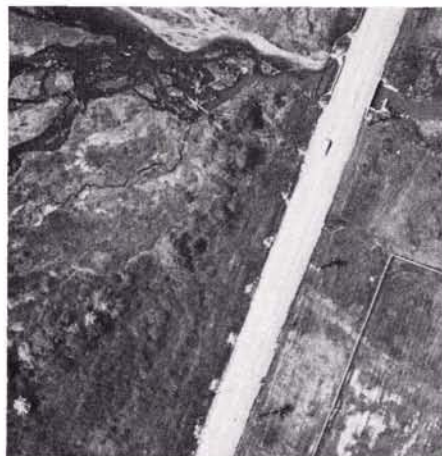
Figure 4 contains an example of detection by gross discoloration. The two discharges to the left of the roadway were bright orange and black. This figure, as all photographic

FIG. 4. Stereo pair of outfalls detectable by gross discoloration. The two outfalls (arrow) are bright orange and black in the original color imagery, black and white in this illustration.

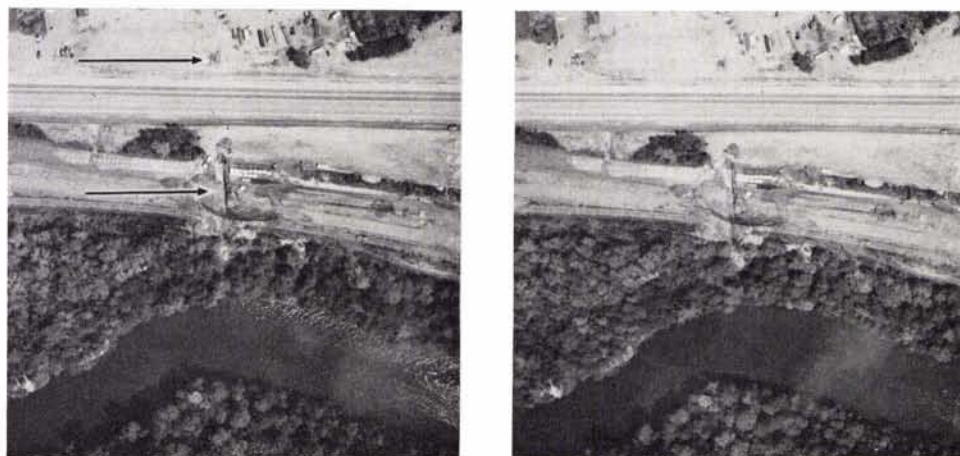
Figures 5 and 6 are stereo pairs which are examples of detection by identification of discharge structures. Figure 5 is of a drainage pipe under construction beneath a railway. Figure 6 depicts a sluice from a treatment pond. Figure 5 is a good example of how

FIG. 5. Stereo pair of drainage pipe under railway. Point of discharge is not visible due to vegetation along river bank. Interpretation of objects removed from the bank, however, enables detection. Rows of white rectangles are aluminum conduits to be placed in cut and subsequently backfilled.

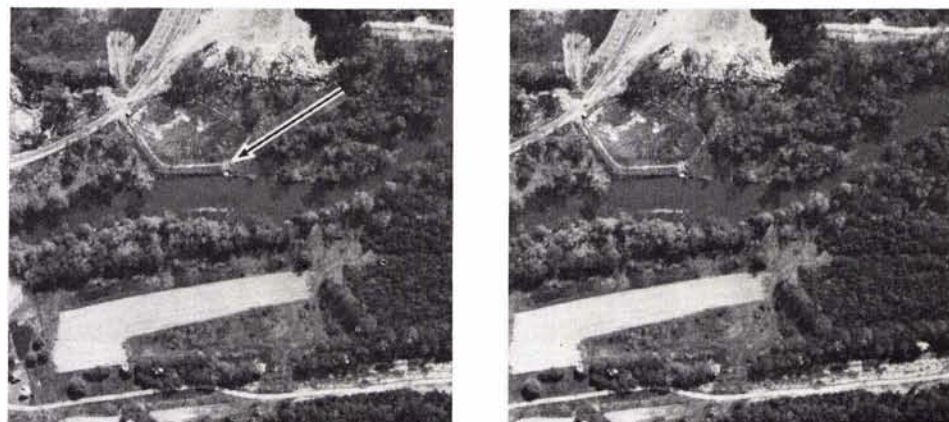
interpretation of objects removed from the stream bank can yield outfall detection, even when the outfall itself is obscured by vegetation. Figure 6 shows an outfall not discharging at time of flight, but detectable by interpretation of discharge structure. Not all outfalls of interest discharge continuously, and it is important to be able to detect outfalls even if dormant. An apparent outfall appears across from the sluice. Inspection of the original color imagery indicates this is river bottom.

FIG. 6. Stereo pair of treatment pond with observable discharge structure (sluice). Outfall probably not discharging at time of flight. Discoloration across from sluice is not a discharge, but river bottom in shallow area of the river.

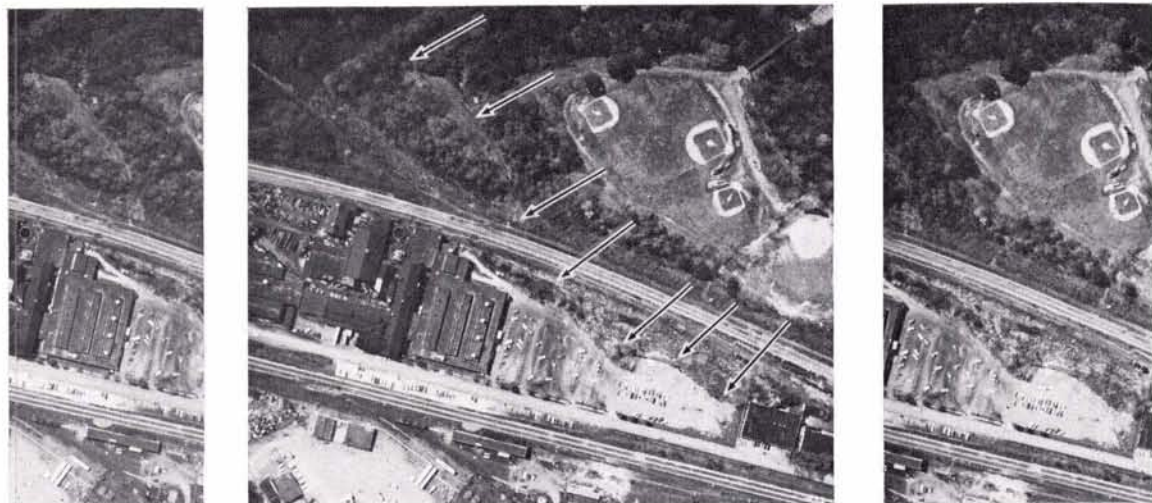
Figure 7 contains an outfall obtained from consideration of drainage patterns. Actual point of discharge occurs well away from the stream bank, and the point of entry into the stream is hidden by vegetation. Without stereo interpretation the presence of this

FIG. 7. Outfall detectable from drainage pattern. Arrows follow drainage pattern from river bank, under railway tracks, to approximate source.

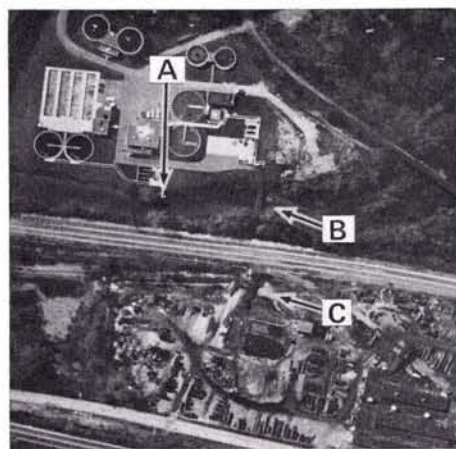
Figure 8 contains one final example of two outfalls. These outfalls occur just downstream (to the left) of the outfall of Figure 7. The upper outfall denoted *A* is from a sewage treatment plant. Detection of this outfall occurred from both turbidity change and close analysis of the shoreline structures. Discharge *B* was detected by turbidity change and analysis of the discharge channel leading back to the treatment ponds denoted by *C*. Both effluents show as a slight whitish tone on the original color imagery.

FIG. 8. Outfall pair just downstream of the outfall of Figure 7. Outfall *A* is from a sewage treatment plant, and is detectable by turbidity change and analysis of shoreline structures. Outfall *B* is detectable from turbidity change and analysis of the discharge channel back to treatment ponds *C*.
