# CASE STUDY OF BEAM DEFORMATION MONITORING USING CONVENTIONAL CLOSE RANGE PHOTOGRAMMETRY

Ivan Detchev<sup>a</sup>, Ayman Habib<sup>a</sup>, Mamdouh El-Badry<sup>b</sup>

University of Calgary, 2500 University Drive NW,  
Calgary, Alberta, T2N 1N4, CANADA

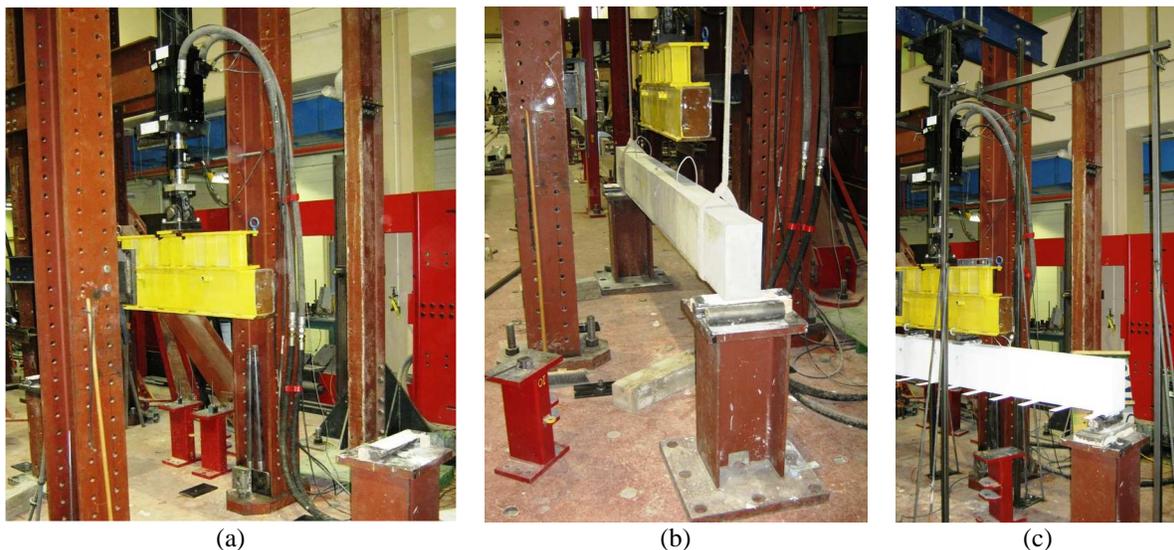
**Figure 1.** Examples of the hydraulic actuator (a), a concrete beam (b), and part of the metal frame (c).

A multiple camera setup needed to be established on both sides of a hydraulic actuator (see Figure 1a) in a civil engineering laboratory. It was to be used to photograph a concrete beam (see Figure 1b) being statically loaded by the hydraulic actuator. In order for the cameras to be able to photograph the beam along the direction at which it is being loaded (i.e. from above as opposed to on the side of the beam), a metal frame (see Figure 1c) had to be designed, and built around the actuator.

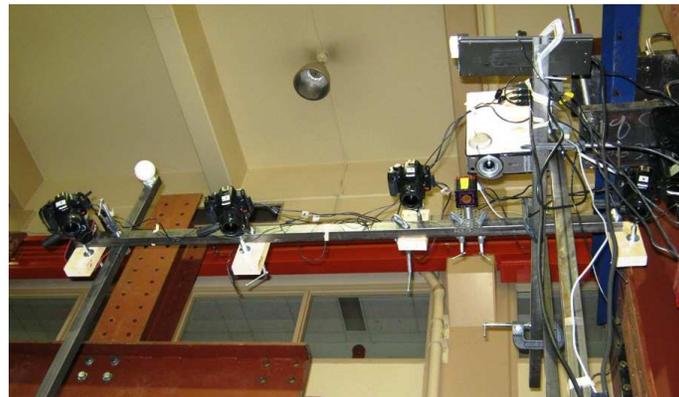
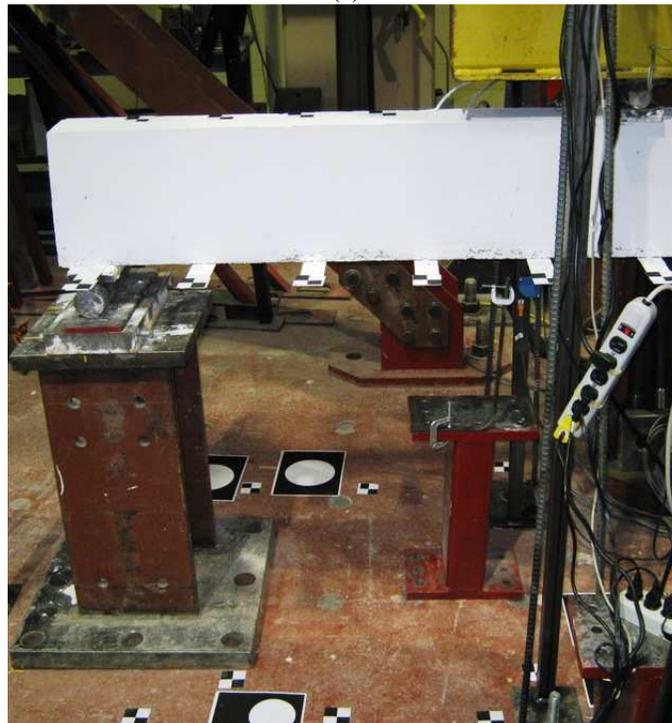
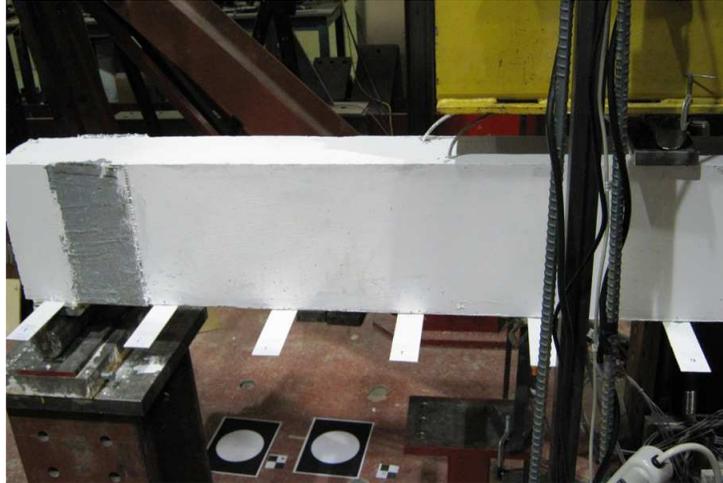
**Figure 2.** Examples of the multiple camera setup (a), the distribution of signalized target points (b), and the removal of the targets from the beam for the rest of the testing (c).

Seven available off-the-shelf digital cameras were mounted on tripod heads, and attached to the top part of the metal frame (see **Figure 2a**). There were three prerequisites that had to be fulfilled before the employed cameras could be used for this project. First, they had to be geometrically calibrated and deemed stable; second, they had to have their relative orientation estimated; and third, they had to be synchronized to operate simultaneously.

The objective of the geometric camera calibration process is to obtain the camera's internal characteristics or interior orientation parameters (IOPs), which include the principal point coordinates, the principal distance, and the lens distortion parameters (Habib and Morgan, 2003). The methodology and the procedures during the camera calibration were previously discussed in Datchev *et al.* (2010). In addition to the geometric calibration, the cameras also had to undergo a stability analysis procedure, which served to verify that the estimated IOPs would not change significantly over time. The stability analysis procedure was necessary, because the cameras were not originally designed for metric applications (Habib and Morgan, 2005; Habib *et al.*, 2005). The methodology for the camera stability testing were explained in detail in Datchev (2010). The location and orientation, i.e. the exterior orientation parameters (EOPs), of each camera station were obtained through a bundle block adjustment procedure using signalized target points spread out on both the floor of the civil engineering lab and on the actual concrete beams (see **Figure 2b**). Since the cameras were rigidly mounted on the metal frame, their relative EOPs were assumed to stay the same for the full duration of the experiments. Thus, the bundle block adjustment for estimating the relative orientation of the cameras was done only once before the beginning of each of the two conducted experiments, and the target points on the beam were removed right before the commencement of the actual testing (see **Figure 2c**).

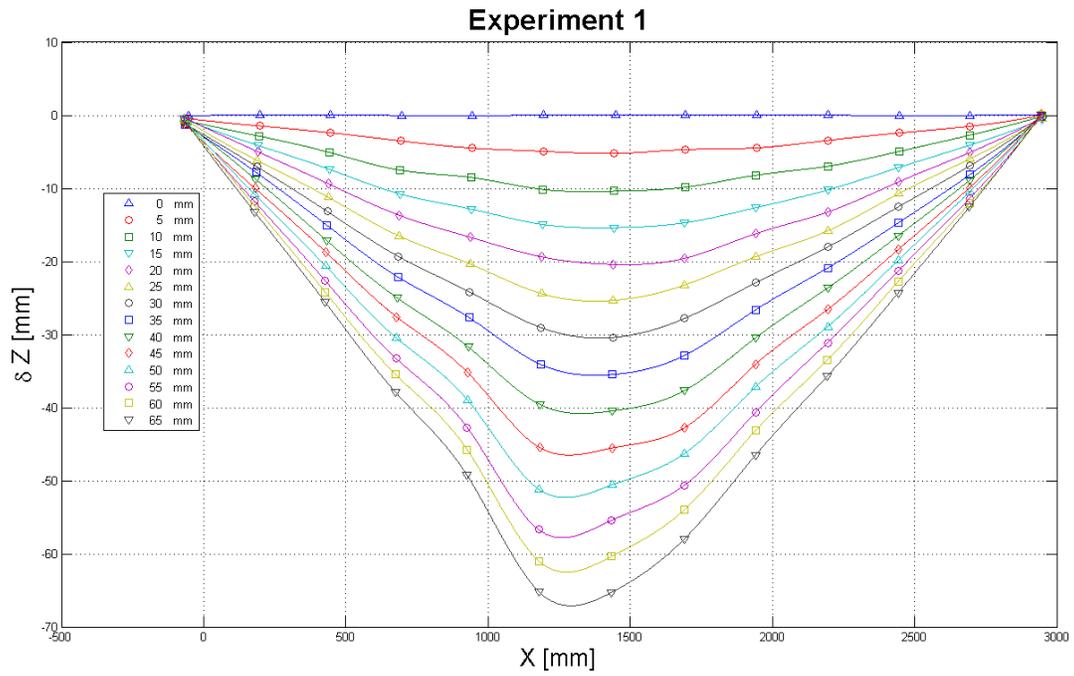
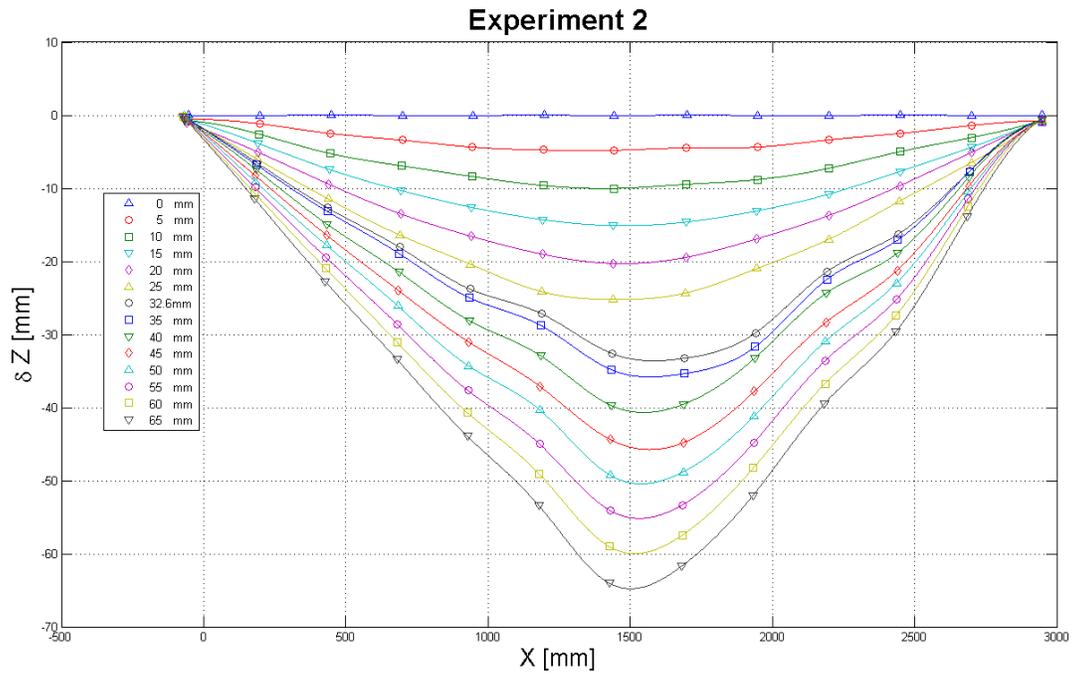
**Figure 3.** Plots of the beam deflections for the first (a), and the second (b) experiments using the manual photo measurements.

So far, only the data from the 1D laser transducers and some manual photo measurements have been processed. The manual photo measurements involved collecting the image coordinates for the four visible corners of each aluminum plate at each loading epoch, and thus reconstructing the four most outside corners of these offset witness plates. Averaging the X, Y and Z object coordinates for the reconstructed four plate corners produced the object space location for the centroids of each plate. Subtracting the Z value of the centroids of each plate for the first epoch from the Z values of the centroids for the same plates for the rest of the epochs yielded the beam deflections ( $\delta Z$ ) at each plate for each epoch. Example plots of Phase II for the two experiments can be seen in **Figure 3**.

In order to check the quality of the photogrammetric reconstruction, the  $\delta Z$  values for plates 5, 7, and 9 from the manual photo measurements were compared to the  $\delta Z$  values from the 1D laser transducers (see Table 1 and Table 2). For the first experiment, the mean for the difference values ranged between -0.3 mm and +0.2 mm, with standard deviations of  $\pm 0.2$  mm and overall root mean square errors (RMSE) of 0.3 mm to 0.4 mm. The results for the second experiment were not as good – the mean for the difference values ranged between -0.5 mm and 2.0 mm, with standard deviations of  $\pm 0.5$  mm to  $\pm 1.7$  mm and overall RMSE of 0.7 mm to 2.6 mm. The reason for the higher deviations for the second experiment was that after the 25 mm load stroke, the polymer sheet separated from the

second beam, and the metal plates got tilted, so their centroids were no longer valid offset witnesses to the true beam deflections.
