Use of Aerial Photographs and Field Reconnaissance for Ice Cap Route Location at Narssarsuaq, Greenland

ROBERT D. LEIGHTY,
*Civil Engineer,
Photographic Interpretation Research Branch,
U. S. Army Cold Regions Research and Engineering Laboratory,
Corps of Engineers*

ABSTRACT: This paper is an illustration of the combined use of aerial photographic interpretation techniques with field and aerial reconnaissance for the purpose of obtaining useful engineering information about terrain conditions for solving highway engineering problems in a remote mountainous area. The purpose of the study was to locate and evaluate an access area from the sea to the ice cap in southern Greenland. The summer of 1957 was devoted to field checking predictions made in a preliminary study of small-scale aerial photography from which a tentative route was located, and location and survey of the route on the ground. Use of aerial photography for study prior to and while in the field resulted in obtaining the maximum amount of information in a minimum of time for location of the road and preparation of an engineering report.

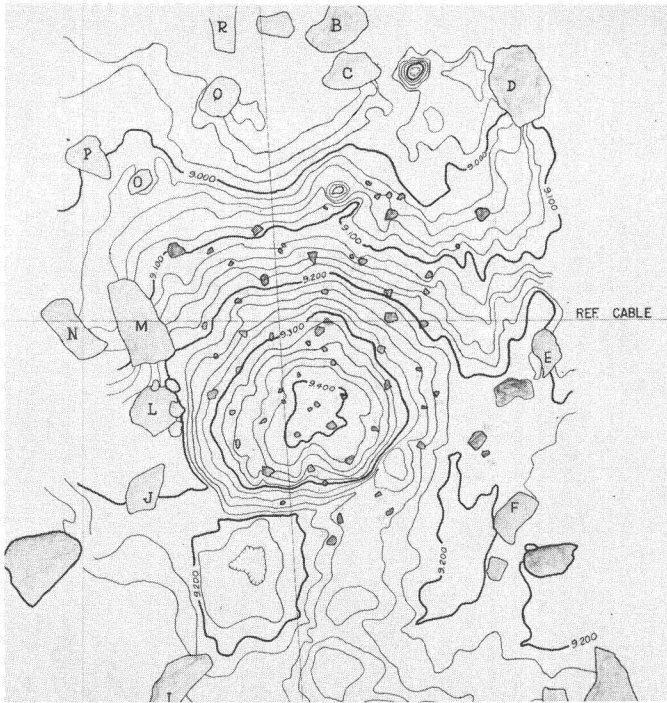
FIG. 12. Soil movement map. Mapping scale of about 1 to 4. Contour interval 0.02 foot.

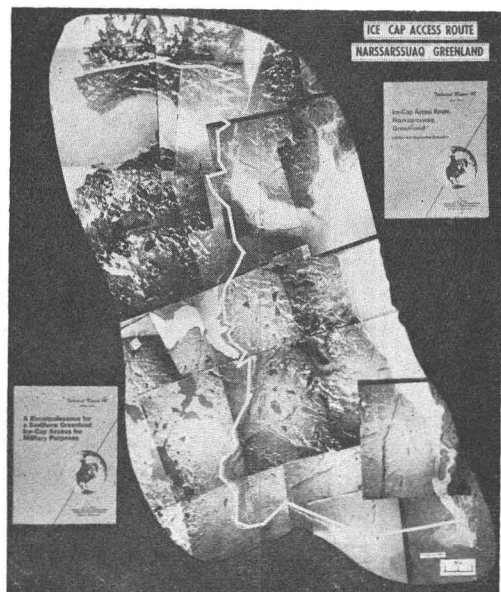
FIG. 2. Aerial mosaic showing location of access route and related USA SIPRE reports.

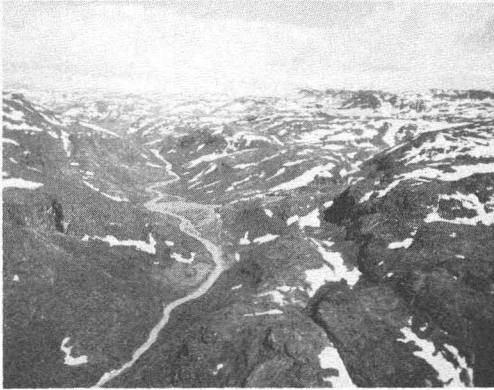
FIG. 3. Typical upland and valley terrain.

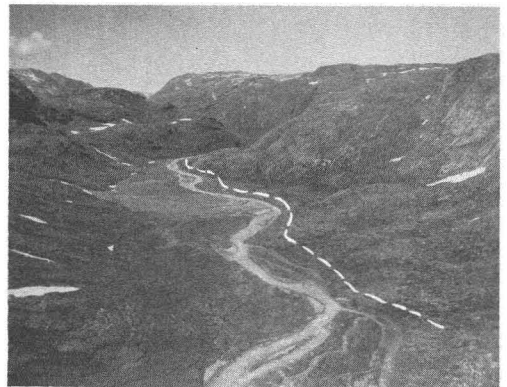
FIG. 4. Valley location of the route.

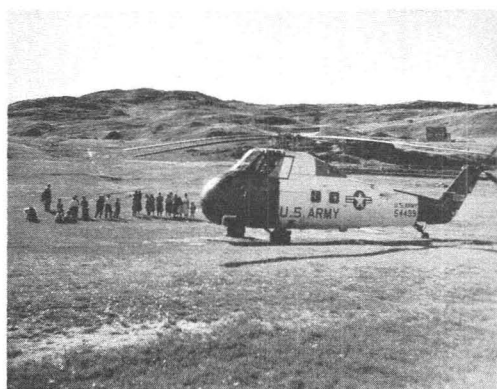
FIG. 5. A H-34 helicopter which supported the project.

Project utilization of the helicopters was considered unique. They were used to move personnel, supplies, and equipment. Their capabilities of carrying twelve passengers without equipment or about seven passengers with their equipment meant that they could carry the complete party into the field at once (Figure 5). Initially the field crews were moved into the field in the morning and back to the air-base each night. This proved to be unsatisfactory when poor weather at the air-base curtailed flying but allowed field work. Thus, parties remained in the field for three or four days at a time and used the helicopters to move the camps and air lift crews and equipment across rivers. Each morning an H-34 would take the reconnaissance party on low flights over terrain to be covered in the succeeding two days. Prior photo study made these reconnaissance flights very valuable.
