H. E. HOLT*
E. C. MORRIS
U. S. Geological Survey
Flagstaff, Ariz. 86001

Interpretation of Surveyor I Lunar Photos

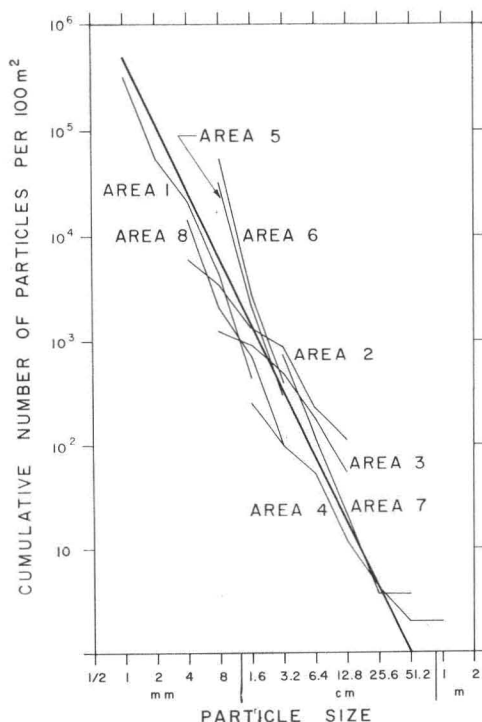
FIG. 14. Cumulative size-frequency distribution of particles on lunar surface as determined from Surveyor 1 pictures.

The cumulative size-frequency distribution of the surface fragments for each sample area, normalized to an area of 100 m.², is shown in Figure 14. The size distribution functions of the fragments in the areas of overlapping resolution are considered as segments of one overall distribution function. Although some heterogeneity occurs from one area to another, the general size-frequency distribution of fragments on the lunar surface around the Surveyor I landing site is estimated by the heavy line in Figure 14, which represents the plot of

$$N = 7 \times 10^5 y^{-2.2}$$

where N is the cumulative number of fragments and y is the diameter of fragments in millimeters. This function extends to particle sizes below the limit of observational data (1 mm.) and indicates that one block about

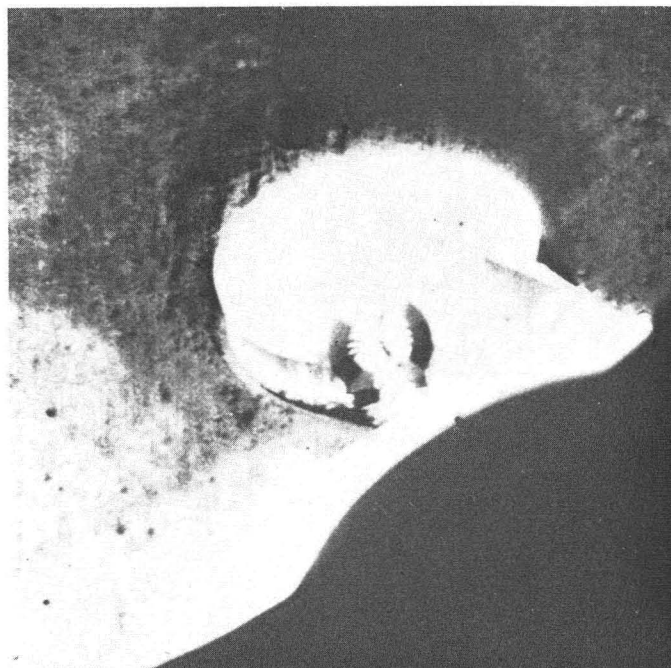
FIG. 15. Raylike deposit of lumpy ejected material extending from the edge of a footpad.

Around the footpads of the spacecraft are raylike deposits of material ejected by the impact of the footpads. Some of the rays extend as far as 1 m., and a distinct ridge occurs near each footpad. This ejected material is dark and is composed of distinctly coarser lumps than the adjacent undisturbed surface material. The lumps in the freshly ejected material (Figure 15) are probably weakly consolidated aggregates of much finer grains and could probably be disaggregated into their constituent grains by moderate pressure or agitation. The mechanical behavior of the fine-grained lunar surface material appears to be similar to that of a dry fine-grained terrestrial soil.
