HARVEY E. DISHAW\*  
*R. C. Thurber & Assoc. Ltd.*  
*Victoria, B. C., Canada*

## Massive Landslides

Difficult to detect on the ground, they are revealed by small-scale photos for construction engineers and geologists.

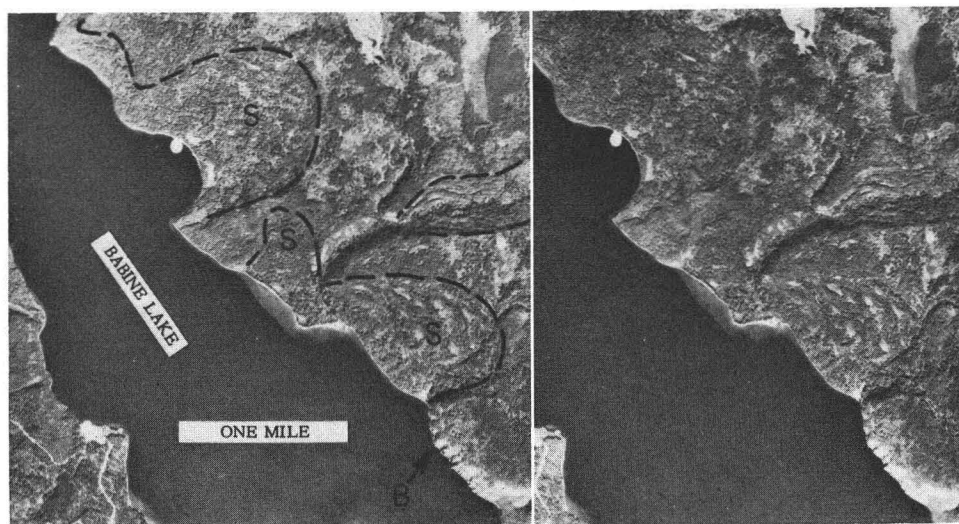
FIG. 1. Massive slumps and earth flows *S* have occurred in deep glacial materials on the north side of Babine Lake in British Columbia. A nearby bluff of columnar basalt *B* shows no sign of instability. Deep glacial materials consist of glacial till and lakebed sediments. These materials were deposited against glacier ice which occupied Babine valley during melting of the glaciers. *Canadian Government Airphoto.*

(Figures 2, 4, 5, 6, and 7), Rockslide and Debris Avalanche (Figure 3), Earthflow (Figure 1) and Block Glide (Figures 2 and 8).

In addition to failures in bedrock, massive landslides have been observed in soil materials (Figure 1). Because of its greater depth, glacier ice in deep valleys was the last to melt. Where a deep deposit of glacial sediments accumulated between the ice and upper valley banks, further melting caused progressive failure of the sediments—the volume of failed material depending on the depth of sediment at the point of failure.

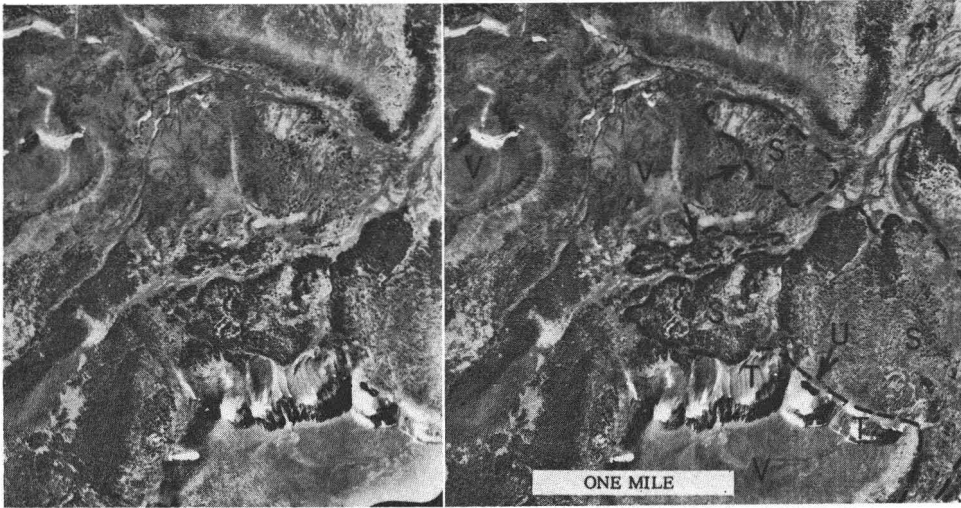
FIG. 6. Mount Downton (7760 ft.), an extinct volcano in the interior of British Columbia was deeply eroded by glaciers during the last Ice Age. Bedrock slumps *S* occurred when glacier ice melted out of *U*-shaped valleys. Scarp faces with associated talus *T* and undrained ponds *U* help to identify sites of massive slides. Unfailed volcanic bedrock *V* has been well rounded by glacial erosion. *Canadian Government Airphoto.*
