WILLIAM J. SCHNEIDER*
U. S. Geological Survey
Washington, D. C. 20242

Color Photographs for Water Resources Studies

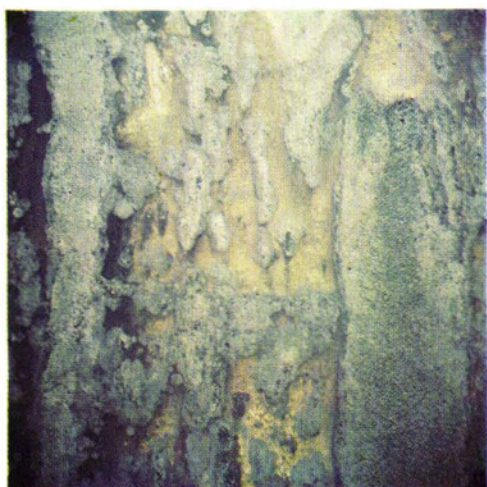
PLATE I. Area of Florida Everglades showing rock reef; from regular color transparency at original scale of 1:6,000.

A further significant item now being studied is the presence of rock reefs across the Everglades which serve as natural barriers to the flow of fresh water. The rock reefs are easily identified by the oriented hammock and sawgrass which form on the slightly higher elevations of the reefs. Excellent examples are shown in Plates I and II. Plate I shows a typical Everglades environment in regular color. The three main ecological communities are the hammocks containing trees which appear as darker green, coarsely-mottled areas on color film, the sawgrass which appears as lighter grey-green more evenly-textured areas on color film, and the open water which appears as light orange-brown areas on color film. Direction of flow is from top to bottom. A line of small hammocks and dense sawgrass on the rock reef that forms a barrier to flow can be readily seen across the center of the photograph. Plate II shows the same area in infrared color. The small hammocks along the reef are more easily identified on infra-red color film because the red color of the trees is in sharp contrast to the blues and greens of the rest of the photograph.

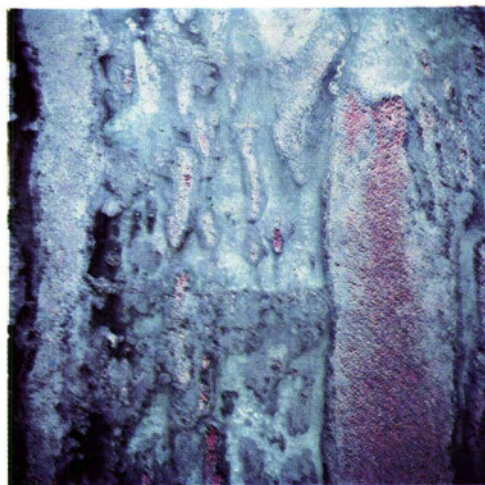
PLATE II. Same area as Plate I; from infrared color transparency at original scale of 1:6,000.

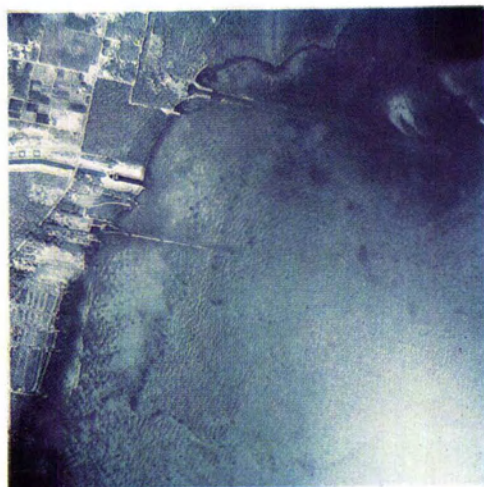
PLATE IV. Shoreline area east of Cutler, Florida showing areas of fresh-water discharge; from regular color transparency at original scale of 1:12,000.

Color photographs are also being used in Florida to identify areas of fresh-water discharge along the coastline. Plate IV shows an area just east of Cutler, Florida. Areas of ground-water discharge into Biscayne Bay can be identified by the presence of *Diplanthera*, a grass that tolerates only moderate salinity, and therefore can grow only in those coastal areas where dilution of sea water by fresh water discharge reduces salinity. In the photograph, the grass can be seen extending seaward from the shoreline for about 300 feet as a solid mass. Beyond this, scattered patches of *Thalassia* occur. Because *Thalassia* will tolerate only very high salinity, the area of fresh-water discharge can be identified as occurring only in the near vicinity of the shoreline.

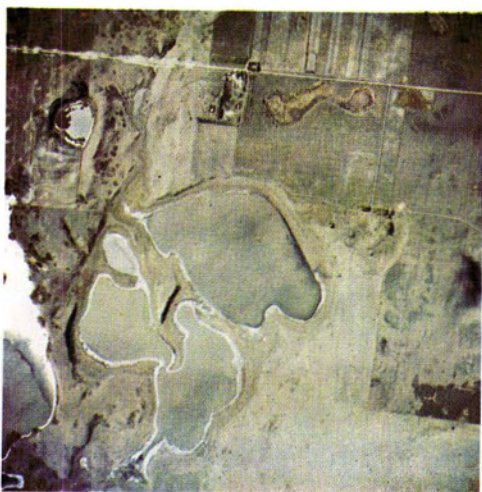
PLATE V. Part of Prairie Pothole area in North Dakota showing differences in salinity of potholes; from regular color transparency at original scale of 1:12,000.

VEGETATION AS an indicator of salinity of water is also being studied in the prairie pothole areas of North Dakota. The potholes are depressions of various sizes and depths which were formed when retreating glaciers left huge blocks of ice in their wake. Today, these depressions contain water which ranges in salinity from near-zero to three times that of sea water. Some preliminary observations from aerial photographs indicate that salinity of the ponds can be determined from the photographs. Plate V shows a typical group of pothole lakes. Water in the individual lakes ranges from fresh to very saline. Although this photograph was obtained in October after a killing frost, vegetation still can be used to infer both salinity of the water and the ground-water conditions that govern the extent of salinity.

The lake in the lower left of the photograph is highly saline. Note the complete lack of aquatic vegetation and also the pres-

ence of white salt deposits along the shoreline. Although the water in the lake in the center of the photograph is saline, the area along part of the shoreline is only slightly brackish as the result of fresh-water inflow from a spring originating in the small clump of trees near the lake. Evidence of ground-water inflow can also be seen in the small lake in the lower right of the photograph. Dense vegetation—trees along the shoreline and aquatic vegetation in the lake—mark an area of fresh water discharge to the lake. In the upper right is a shallow dry pothole covered with fresh-water vegetation.

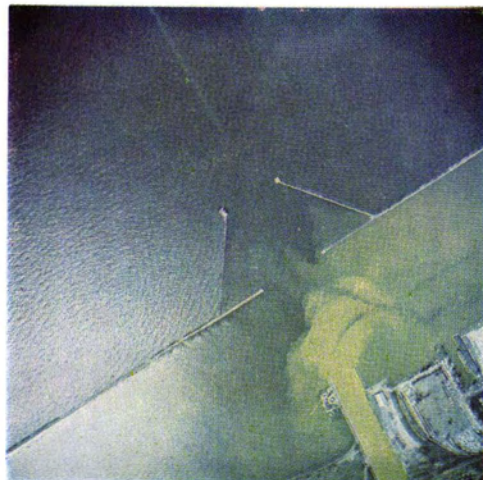
PLATE VIII. Lake Erie at Cleveland, Ohio showing discharge of Cuyahoga River; from regular color transparency at original scale of 1:8,000.

In preliminary reconnaissance studies of Lake Erie, color photographs have been used to identify flow patterns, especially as related to the discharge of polluted wastes to the lake. It has been especially useful in the appraisal of water-quality data obtained at specific locations in the lake. The photography has been invaluable in assessing the circulation patterns in the vicinity of the mouths of rivers so that continuous water-quality monitors may be located in representative lake environments. A common flow pattern is shown in Plate VIII. Shown here is the Cuyahoga River as it enters Lake Erie at Cleveland, Ohio. The industrially polluted river water diffuses as it is carried eastward on the lake surface by the prevailing wind. Evidence of the warmer river water overriding the cooler lake water is seen in the boat wakes in which the upper layer of water has been mixed sufficiently with the underlying lake water so that the wake appears quite similar to lake water.
