Photogrammetric Monitoring of a Gabion Wall*

Terrestrial photogrammetry was employed to determine temporal deformations.

ABSTRACT: The gabion wall, which is being built as part of the Interstate Highway 90 east of Seattle, Washington, is being monitored by the terrestrial photogrammetric method. A modified KA-2 camera, $f = 610$ mm (24"), format size 23×23 cm ($9" \times 9"$), glass plate, is being used for this purpose. The establishment of the "base net" for the camera stations has been accomplished with EDM and theodolite of 1/10 of one second least reading. The design of the geometry of the camera stations and their measurements are discussed. The method by which the photogrammetric monitoring was performed is described and its accuracy is presented. A typical deformation of a target in the horizontal direction is shown.

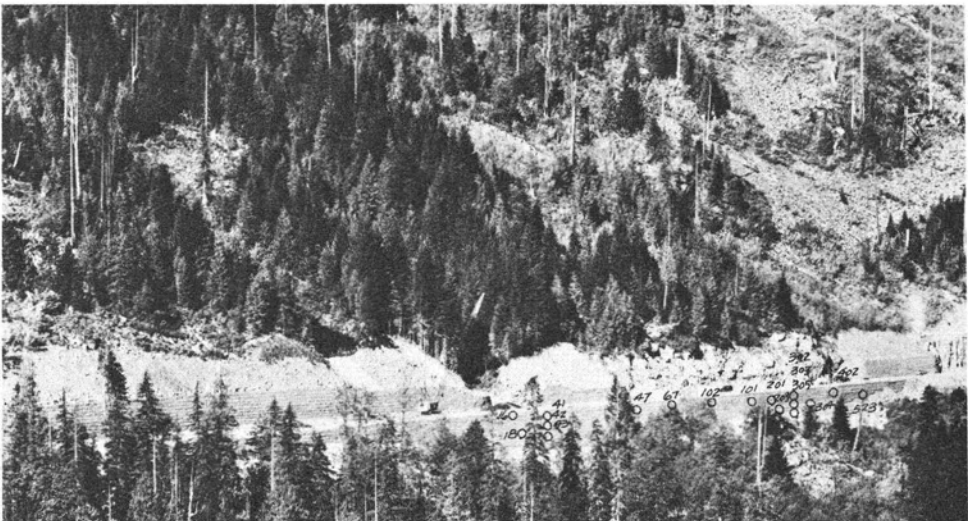
The gabions for this project are three feet by three feet by three feet of steel wire mesh filled with rocks. It was constructed as a gravity wall with native rock and weighs 100

pounds per cubic foot. The wall being monitored is 1200 feet long and varies in height from 5 to 54 feet depending upon the topography. This is an experimental design and is believed to be the largest in the nation. Part of the wall is shown in Figure 1 where the upper and lower portions of the wall are clearly distinguishable.

FIG. 1. Gabion wall.

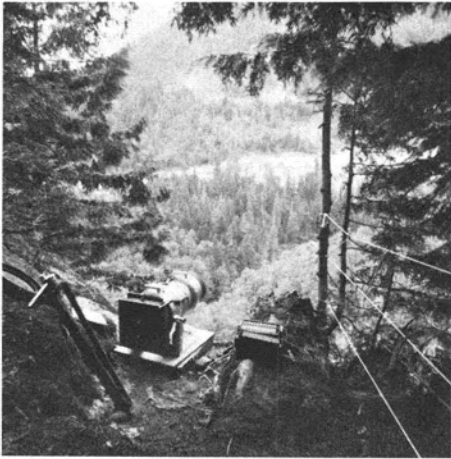
There are no metric terrestrial cameras manufactured to these specifications. Therefore, a KA-2 aerial camera was modified for this purpose. The modification consisted in adding two supporting rings and a magazine with plate holders. The camera is exhibited in Figure 2. The calibration of the camera was done by the U.S. Geological Survey in Reston, Virginia.

FIG. 2. Modified KA-2 camera and camera Station #2.

Three permanent camera stations were anchored to bedrock by 3 cm × 3 cm reinforcement bars which were threaded on top in order to attach the camera mounts for each respective station. A drilling jig was prepared by the Washington State Highway Department's Soil Testing Laboratory to aid in alignment. The area was filled with concrete to provide a permanent camera station

with mounts for the monitoring. The illustration of the number two camera station with the camera is shown in Figure 2.

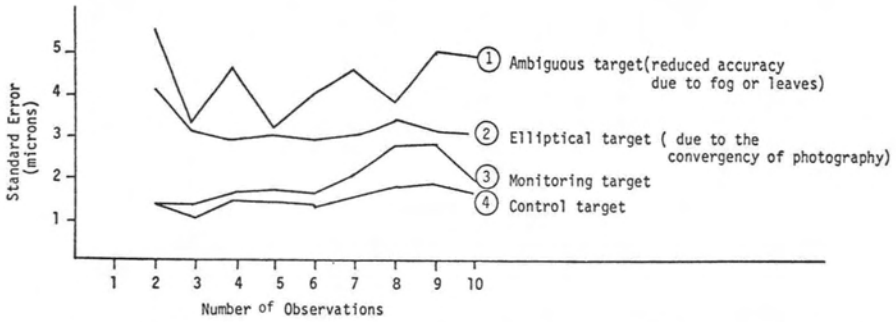
The photographic coordinates were obtained on the AP/C analytical stereoplotter at the University of Washington. The accuracy of the photo coordinates was obtained by making five observations, and it varied according to the nature of the targets. The general evaluation of achieved results is shown in Figure 8. This figure shows that the standard error in the case of ambiguous targets is about 5 micrometers. In other

FIG. 8. Pointing analysis. Note: The data obtained from 100 man-hours experience.

cases the standard errors are less. These results proved to be satisfactory.
