# Monitoring a Gabion Wall by Inclinometer and Photogrammetry

A combination of the two methods was found to be best.

*ABSTRACT: There are a number of methods which may be used to monitor structural deformations. The comparison and analysis of two are discussed. A photogrammetric system is employed as an external method and an inclinometer system is used as an internal method. The general flow of data for the photogrammetric system along with the principle and use of an inclinometer are described. The comparison and analysis are possible in several ways; however, the general conclusion is that the best monitoring system is a combination of the two methods.*

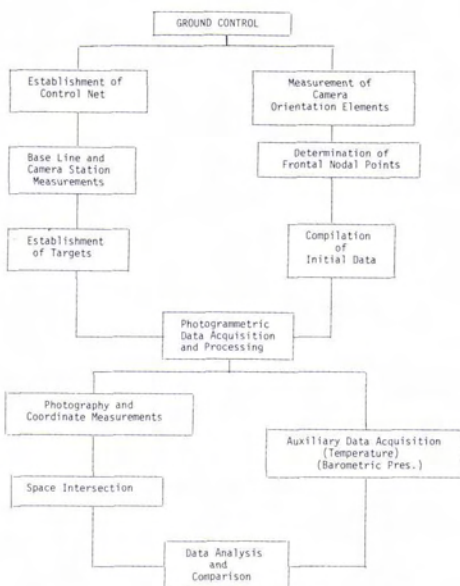
FIG. 1. Photogrammetric method.

A flow diagram is given by Figure 1 and is discussed in detail by Flint (1975), Sinco, Slope Indicator Company (no date), Veress *et al.* (1977), and Veress and Sun (1978). The general layout of the photogrammetric project is shown by Figure 2.

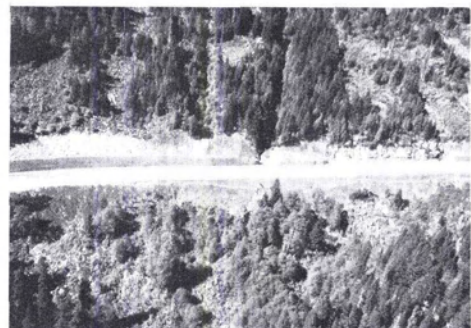
FIG. 3. Construction site.

A bird's-eye view of the construction site is shown by Figure 3. The structure is located on the west side of the valley and the camera stations were placed on the east side at about 3,000 feet (1 km) from the wall.

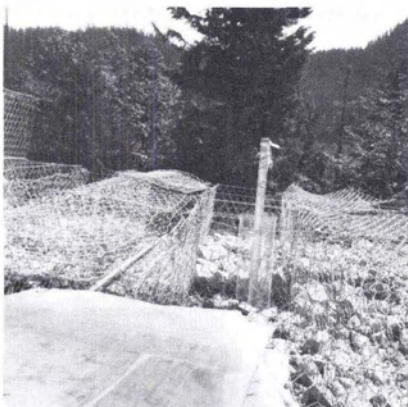
FIG. 6. Installation of inclinometer.

An inclinometer casing was installed by the Washington State Department of Transportation at two locations in the gabion wall. These locations were chosen considering the normal height with the most uniform backfill conditions for all internal instrumentation. Both of these locations have photogrammetric targets on their surfaces (the 40 and 60 series). This provides the basis for comparison between external and internal monitoring. The photograph on Figure 6 shows the installation of the two inclinometer casings during construction.
