Investigations of Hazardous Waste Sites Using Thermal IR and Ground Penetrating Radar

Gary J. Weil, Richard J. Graf, and Leann M. Forister

Photogrammetric Engineering & Remote Sensing,
Vol. 60, No. 8, August 1994, pp. 999-1005.

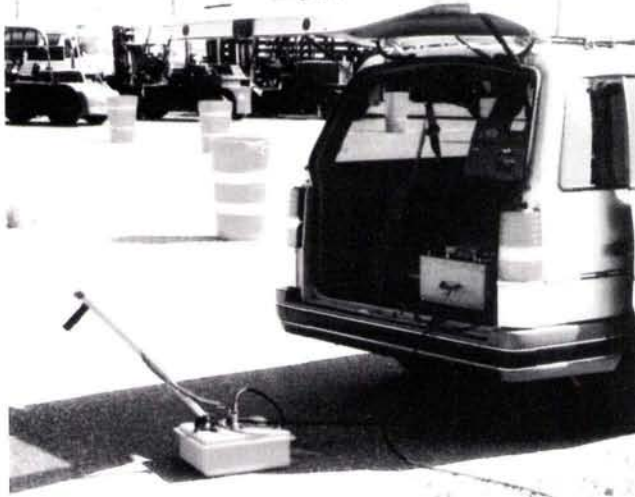
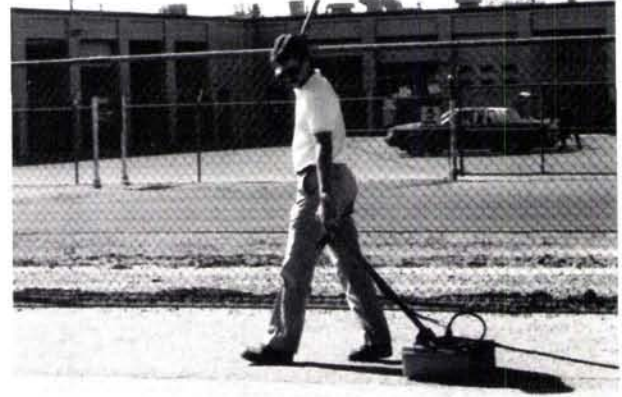
SUPPORT ELECTRONICS & RECORDING DEVICES:

RADAR ANTENNA MANUAL TOW SYSTEM:

Figure 2. GPR data collection.

The ground penetrating radar (GPR) system uses an antenna to transmit controlled electromagnetic pulses that are transmitted into the subsurface areas in question. The pulses penetrate the subsurface and are reflected back to a receiving antenna. The radar system amplifies and enhances the pulses, which are then recorded on data tape and simultaneously displayed in real-time on a color monitor (Figure 2).

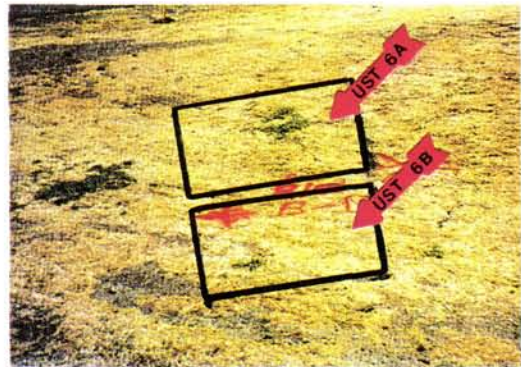
RADAR PROFILE:

UST 6A & 6B

LOCATION: US. Air Force Base
California
35 feet SE of building 87C

DEPTH: UST 6A - 4 feet
UST 6B - 7 feet

SIZE: UST 6A - 500 Gallon Approx.
UST 6B - 500 Gallon Approx.

INFRARED THERMOGRAM:

VISUAL IMAGE:

Plate 1. Combined visual, IR, and GPR data of UST.

The combined data results from both the TIR and GPR investigations confirmed the location, horizontal size, depth to the top surface of the anomaly, and construction type, metal or non-metal, of 36 USTs (Plate 1). In addition, two of the 36 sites were found to contain contaminated soils surrounding the UST location. The contamination evidenced itself in both the TIR and the GPR tests. In the TIR test, the plumes thermal characteristics differed from those of the surrounding materials. This difference caused a warmer surface temperature in the areas covering the plume. In the GPR tests, the contamination showed up as obvious differences in the dielectric value of the subsurface materials. The remaining two locations identified by thermal imaging as containing subsurface anomalies were confirmed by GPR, and minor soil disturbance, to be the location of an abandoned utility line and a buried automobile tire, both of which were located under a dust covering near the ground surface. The above results were confirmed by independent government contractors during their site rehabilitation program.
