ROBERT J. HACKMAN
U. S. Geological Survey
Washington, D. C.

Interpretation of Alaskan Post-Earthquake Photographs*

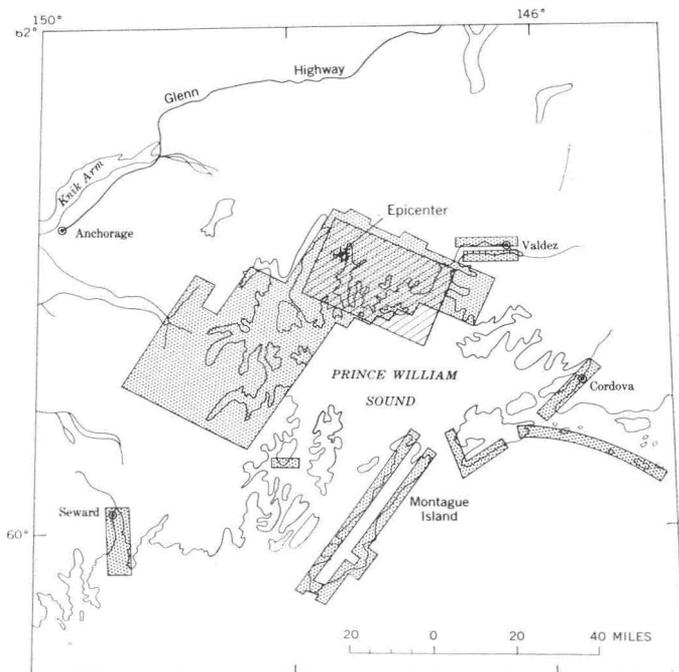
FIG. 1. Area covered by post-earthquake photography (stippled). Diagonal lines designate area of post-earth slides and avalanches around epicenter of earthquake (Figure 9).

Figure 1 shows the area of new photo coverage used in this study. The objective of the study was to determine quickly whether geologic features resulting from the earthquake, such as faults, changes in shoreline, cracks in surficial material, pressure ridges in lake ice, fractures in glaciers and lake ice, and rock slides and avalanches, might be identifiable
