DAVID W. GAUCHER
Calspan Corporation
Buffalo, NY 14221
JAMES D. TURINETTI, CAPT, USAF
Rome Air Development Center
Griffiss AFB, NY 13441
KENNETH R. PIECH
Calspan Corporation
Buffalo, NY 14221

Special Color Analysis of Runway Conditions

Regions of cracking or depressions in the runway at Thule Air Base, Greenland were determined from color aerial photography.

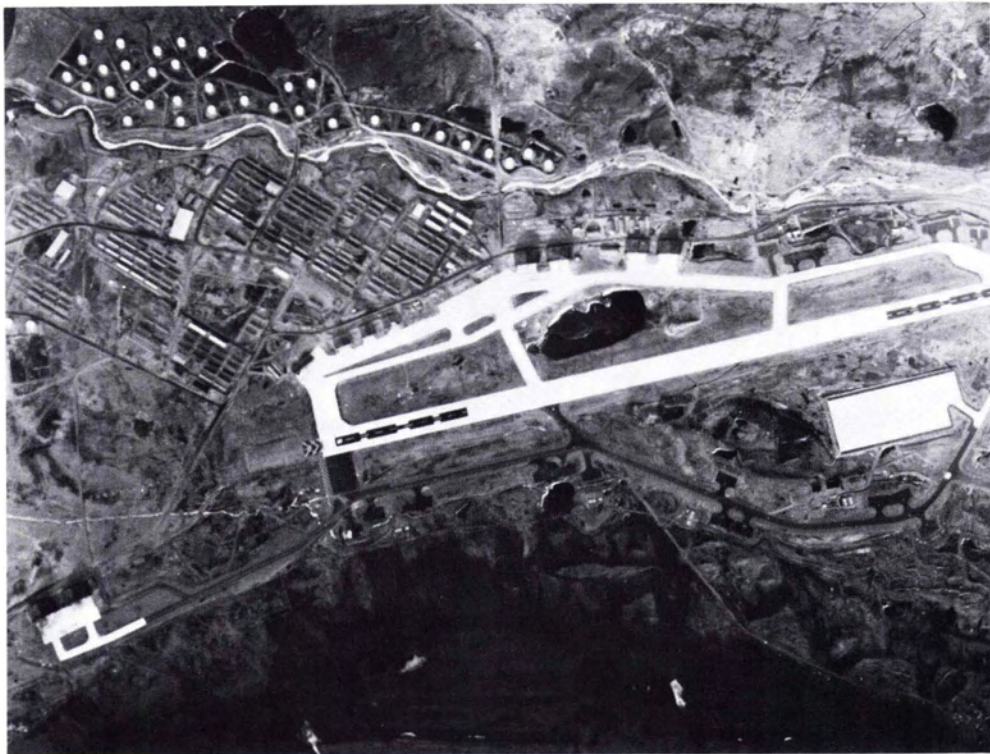
FIG. 1. Thule Air Base, Greenland.

As a result of a request to RADC for support in obtaining visual photography and infrared scanner imagery of Thule Air Base, RADC Flight Test Division's C-131s over-flew that installation in 17/18 Sep 74. Figure 1 is an image of that airfield and is a copy of the scene used for the subsequent analysis of Thule's runway condition. Spectral information contained in that scene was enhanced by using the SCAT console in order to provide
