FRANK J. WOBBER, PH.D.\*  
*IBM Space Systems Center  
 Bethesda, Maryland*

## Fracture Traces in Illinois

Surface identification of bedrock jointing  
 150 feet beneath helps locate water well sites.

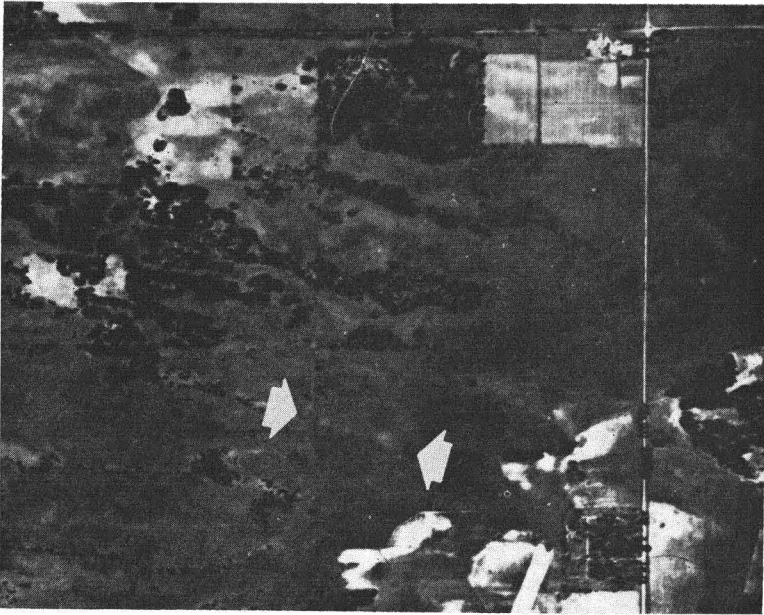
FRONTISPIECE. Area of sandy to clayey ground moraine and crevasse fillings, South-central Dupage County, Illinois. Solid arrows indicate fracture trace which is approximately aligned with light-colored, sandy crevasse deposits to the left. (See text page 502.)

Glaciated midwestern areas as exemplified by Dupage County, offer a unique set of problems in photogeological fracture mapping. Receding glaciers have in places deposited radial to subradial crevasse fillings (Frontispiece) which remain as subtle tonal patterns despite cultural activities. In areas of low relief, or in the absence of careful stereoscopic study, such landforms often suggest fracture traces. The cross-deposition of crevasse fillings (the so-called *waffle pattern*)

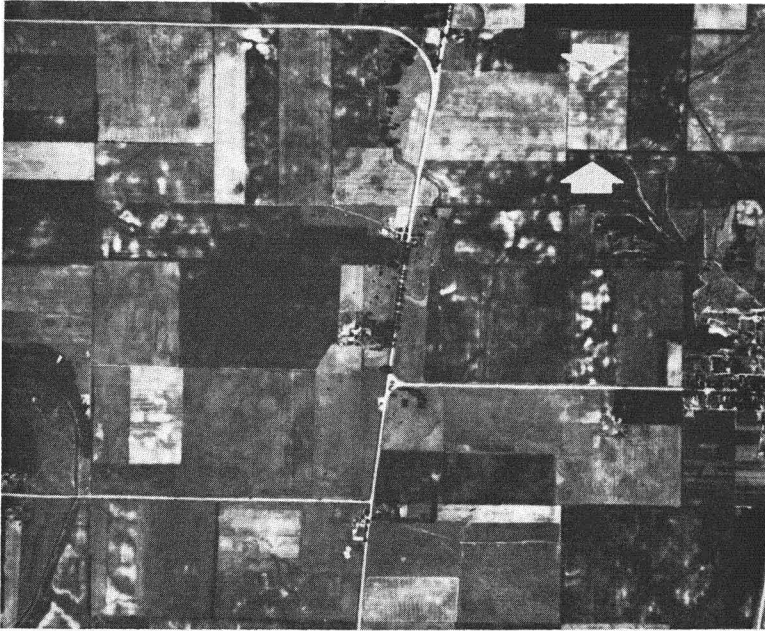
FIG. 3. Area of Tinley ground moraine, northeastern Dupage County. Mottled appearance is generally characteristic of tills in the midwestern United States. Arrows indicate one (and possibly two) fracture traces trending N 5°E.

Soil-tonal differences have proven to be the primary indicator of photogeological fracture traces in northeastern Illinois (Figures 3 and 4). Complementary field studies reveal that darkly imaged lineaments identified photographically are either extremely gentle topographic sags, or lack apparent surface expression. Study in areas of fracture traces indicates that surface moisture apparently moves both *towards* areas of fracture traces and *downwards towards* the jointed bedrock surface.

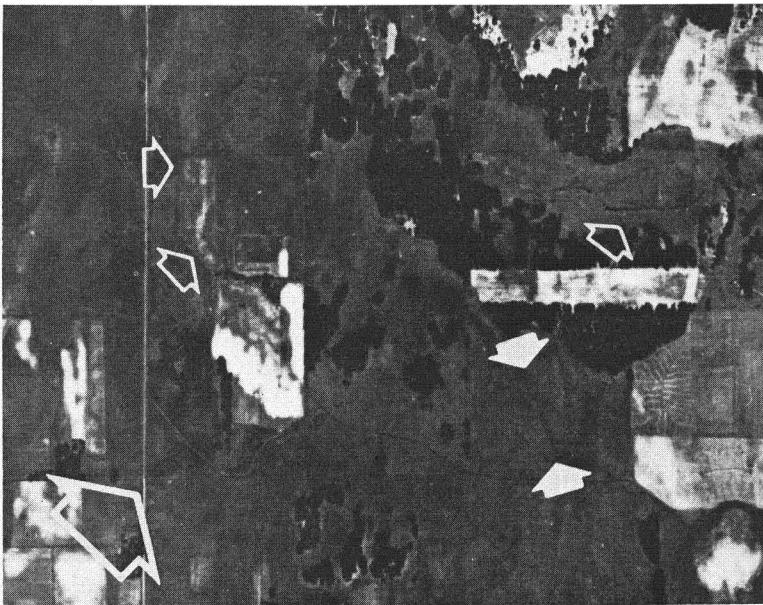
FIG. 4. Area of clayey ground moraine, northeastern Illinois, depth not exceeding 30 feet in this photograph. Solid arrows indicate fracture trace defined by soil tonal differences; other arrows indicate straight stream segments. Quarrying operations in bedrock dolomite are underway to the east. True North indicated by large arrow.
