FRANK J. WOBBER, PH.D.*
*IBM Space Systems Center
 Bethesda, Maryland*

Fracture Traces in Illinois

Surface identification of bedrock jointing
 150 feet beneath helps locate water well sites.

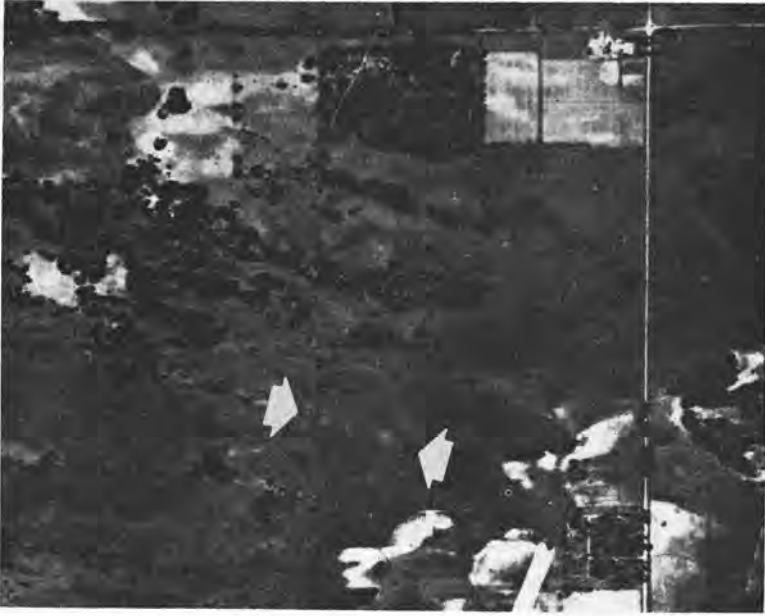
FRONTISPIECE. Area of sandy to clayey ground moraine and crevasse fillings, South-central Dupage County, Illinois. Solid arrows indicate fracture trace which is approximately aligned with light-colored, sandy crevasse deposits to the left. (See text page 502.)

Glaciated midwestern areas as exemplified by Dupage County, offer a unique set of problems in photogeological fracture mapping. Receding glaciers have in places deposited radial to subradial crevasse fillings (Frontispiece) which remain as subtle tonal patterns despite cultural activities. In areas of low relief, or in the absence of careful stereoscopic study, such landforms often suggest fracture traces. The cross-deposition of crevasse fillings (the so-called *waffle pattern*)

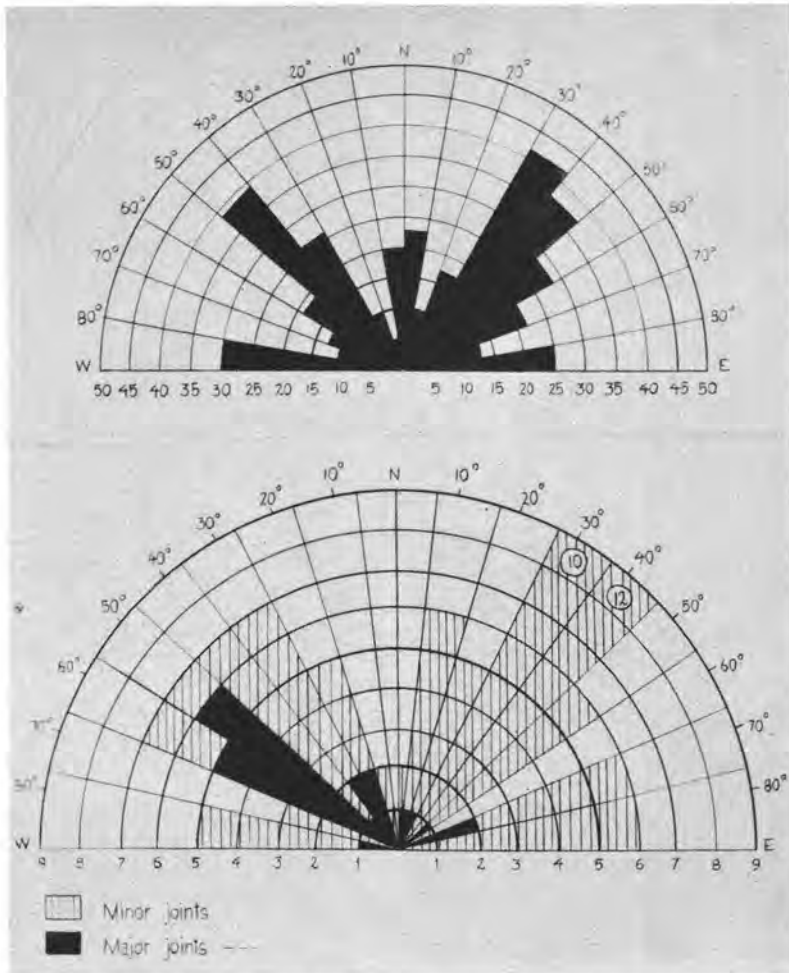
FIG. 2. Rose diagrams of joint direction as determined by fracture trace analysis of (*upper diagram*) aerial photographs of Dupage County, Illinois, and (*lower diagram*) field measurements of joint directions in the same area. Supplementary field data from Zeitzel⁶ indicates an average joint trend in Dupage County of N 50°E and N 47°W. Average joint trends determined photogrammetrically by author were N 50°E and N 44°W.

jointing in the dolomite bedrock. This is reflected by a close correlation between field measurements of bedrock fractures and photogrammetric data as presented in Figure 2.

Fracture-trace analysis and field studies by the author suggest that two major bedrock-joint sets lie at approximately right angles to one another in Dupage County. These field studies have been summarized in Figure 2, and a comparison has been drawn to photogrammetric fracture-trace measurements.

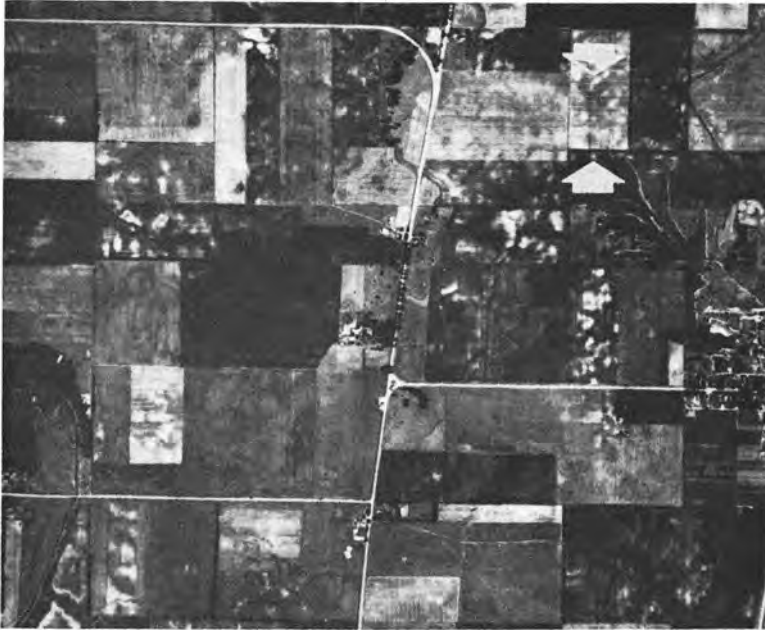
FIG. 3. Area of Tinley ground moraine, northeastern Dupage County. Mottled appearance is generally characteristic of tills in the midwestern United States. Arrows indicate one (and possibly two) fracture traces trending N 5°E.

Soil-tonal differences have proven to be the primary indicator of photogeological fracture traces in northeastern Illinois (Figures 3 and 4). Complementary field studies reveal that darkly imaged lineaments identified photographically are either extremely gentle topographic sags, or lack apparent surface expression. Study in areas of fracture traces indicates that surface moisture apparently moves both *towards* areas of fracture traces and *downwards towards* the jointed bedrock surface.

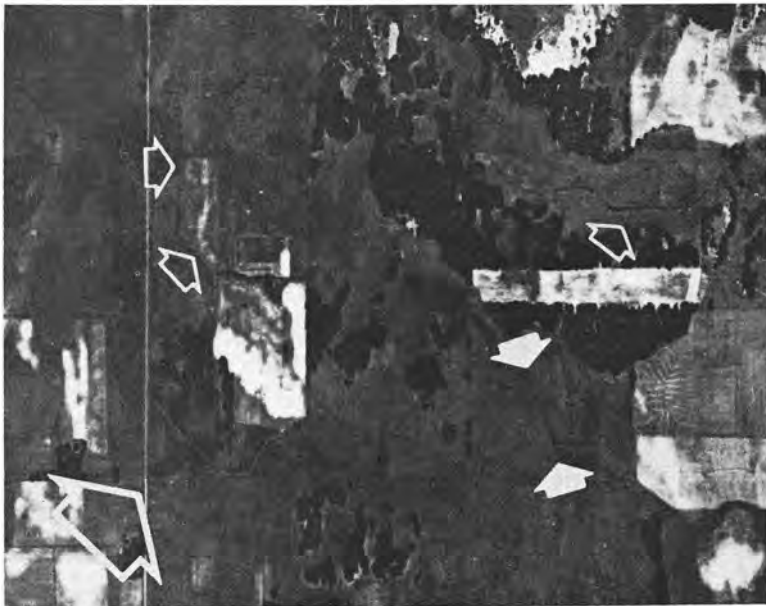
FIG. 4. Area of clayey ground moraine, northeastern Illinois, depth not exceeding 30 feet in this photograph. Solid arrows indicate fracture trace defined by soil tonal differences; other arrows indicate straight stream segments. Quarrying operations in bedrock dolomite are underway to the east. True North indicated by large arrow.
